Seismic Performance and Failure Mechanisms of Reinforced Concrete Structures Subject to the Earthquakes in Türkiye

Abstract: Many reinforced-concrete structures collapsed or were seriously damaged in the 7.7 and 7.6 magnitude earthquakes that occurred in southern Türkiye on 6 February 2023. The recorded peak ground accelerations were quite high (2.2 g) and the recorded motions' elastic acceleration response spectra were significantly greater than the elastic design spectra given by the most recent Turkish seismic design code. A total of 518,000 houses were heavily damaged or collapsed in the eleven cities affected by the earthquake. More than 53,000 people lost their lives and over 100,000 people were injured, the majority of these injuries caused by the collapse of reinforced concrete structures. Post-earthquake damage assessments are important in the context of applying sustainability principles to building design and construction. In this study, post-earthquake damage assessments and evaluations were made for the reinforced-concrete structures that were exposed to destruction or various structural damage in Hatay, Kahramanmaraş and Adıyaman, which were most affected after the K

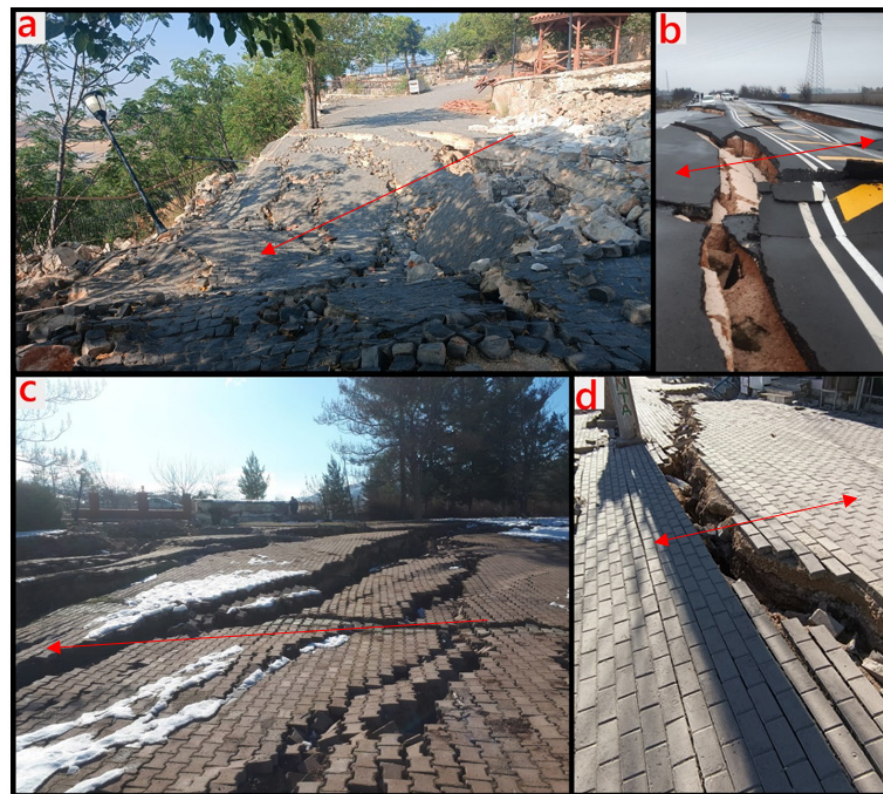
Local soil conditions directly affected the earthquake performance and structural damage levels of buildings in the Kahramanmaraş earthquakes, like in other major earthquakes. As a result of field assessments, ground-related structural damage was frequently observed, especially in settlements such as the Gölbaşı district of Adıyaman province, Kahramanmaraş (Kuyumcular and Çiğli Village), Antakya and İskenderun. In addition, earthquake effects have been clearly observed on the ground surface in different ways. One of these has been lateral spreads that occurred in the ground surface. As a consequence of lateral spreading, cracks, steepness, and depressions occur. Some samples of lateral spreading are shown in Figure 6. Lateral spread towards a free face is seen in Figure 6a,c, whereas in Figure 6b,d lateral spread down gentle slopes is shown, where a free face is absent.

Figure 6. Ground-related damage after the earthquakes; (a,c) lateral spread towards a free face; (b,d) lateral spread down gentle slopes.

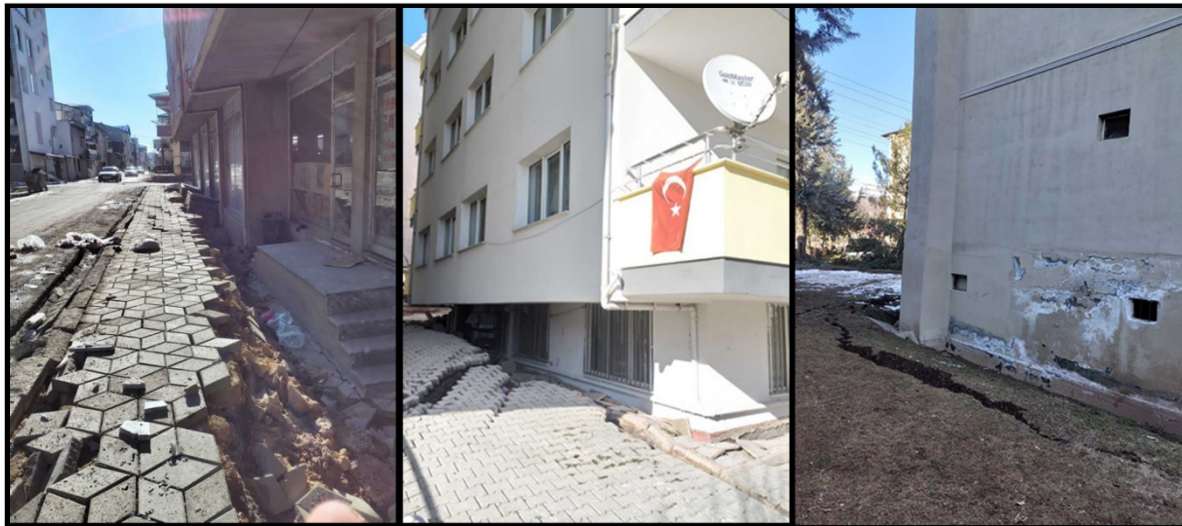
Liquefaction of the soil is the loss of its strength, hardness and solidity as a result of earthquake shaking or similar rapid and heavy loading. When the layers under the level of groundwater quickly become weaker and behave more like a viscous liquid than a solid, this is known as ground liquefaction. Liquefaction damage is shown in Figure 7.

Figure 7. Damage caused by liquefaction.

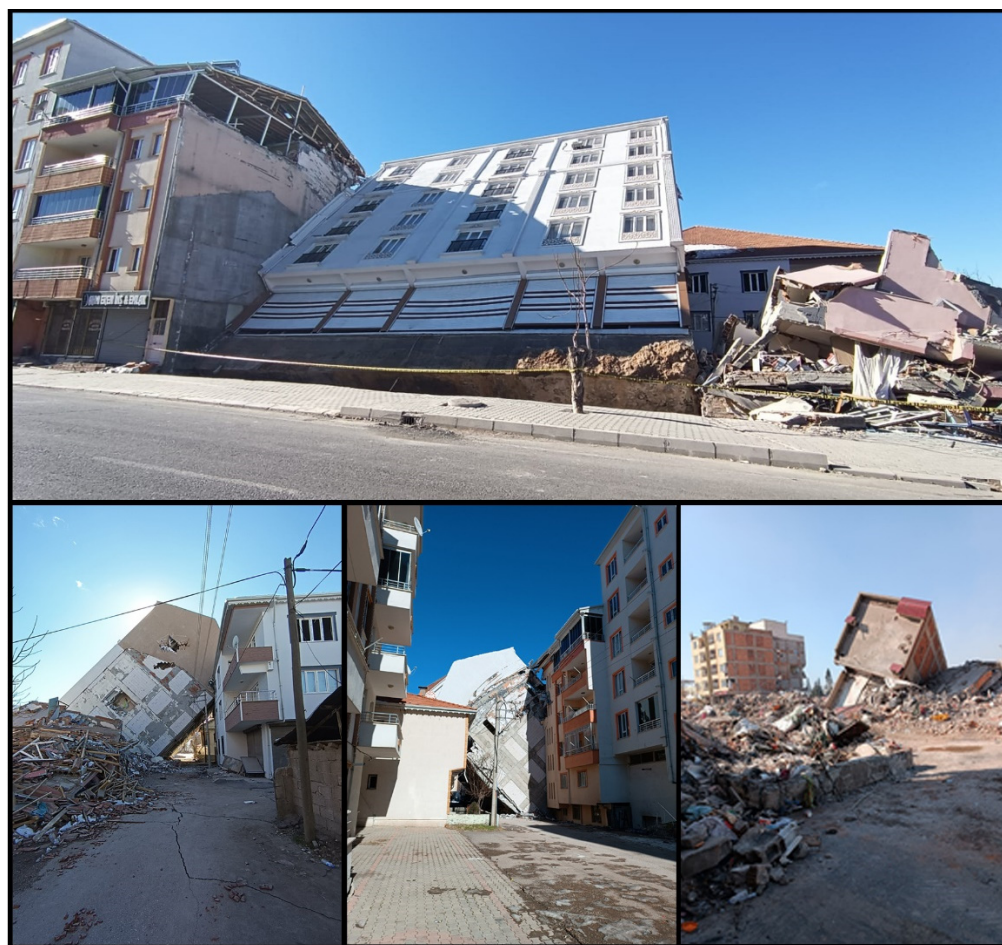
Foundation settlements and rotations may occur due to the bearing capacity of the soil, whose shear strength decreases due to liquefaction. As a result of these, structural damage may occur when structures on such soils rotate away from the foundation and overturn.

In Figure 8, such damage is displayed. Additionally, insufficient foundation depth and weak design of structure–soil interaction are other factors that contribute to such damages.

Figure 8. Examples of the lack of sufficient foundation depth.

Local soil conditions must be determined realistically by in situ geotechnical tests. In addition, soil–structure interaction must be taken into consideration realistically in building design. Foundation type, foundation width, length, and depth selections should be made accordingly. In addition, if the soil properties are very poor, ground reinforcement methods should also be considered. Necessary precautions should be taken, especially on the ground, where there is a risk of liquefaction. In addition, basement floors, which have a positive effect on the earthquake performance of the building, should be considered and implemented in building construction. In this context, the currently used Turkish Building Earthquake Regulation (TBEC-2018) [77] has paid special attention to this situation with very detailed and different sections regarding both local ground and foundations.

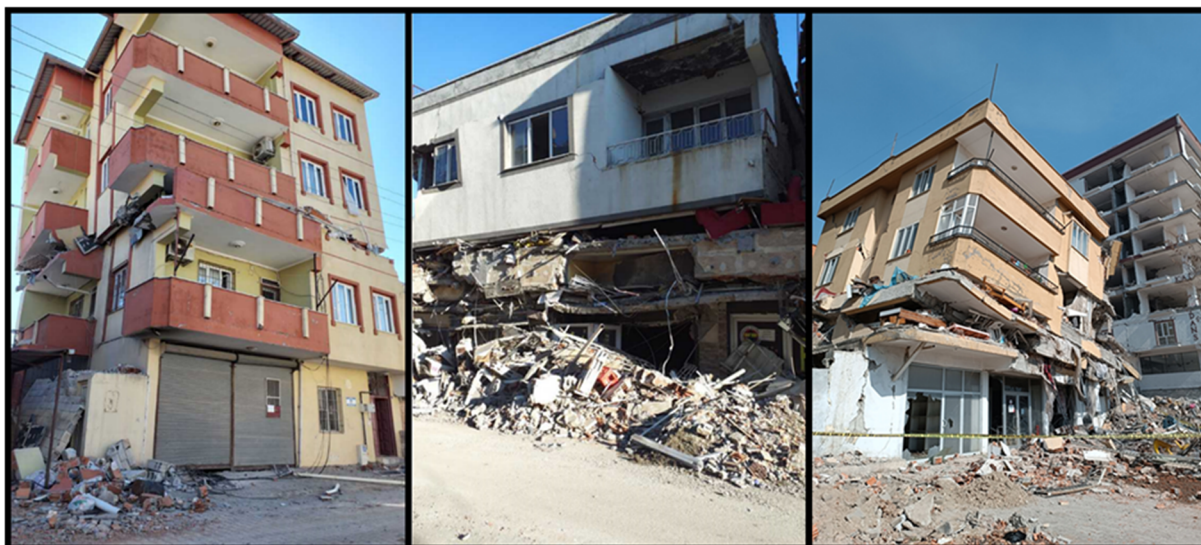
As a result of the difference in stiffness/strength between stories in a reinforced concrete building, a weak/soft story is formed. Soft story formation has been observed for many different reasons, such as changing the load-bearing system between stories or using different flooring systems between stories. Soft story irregularity is among the most important causes of building damage during earthquakes. This irregularity is included in almost every post-earthquake examination report. Although some stories of the buildings had completely collapsed, it can be seen that even the windows of the upper stories had not broken. Soft stories may occur due to the building load-bearing systems having different characteristics between floors (such as high story heights) or due to the change in the number of partition walls, which are not considered to belong to the load-bearing system. The collapses that occurred on the intermediate floors are shown in Figure 9.

Figure 9. Samples of weak story damage.

Irregularities that create a weak or soft story mechanism in any story should be avoided. In this context, necessary precautions should be taken in the building load-bearing system to eliminate the negative effects of sudden stiffness and strength decreases caused by the removal of infill walls, which are not taken into account in the load-bearing system calculation but may have significant stiffness in their planes, on some floors and especially on the ground floors of buildings. Care should be taken not to change the purpose of use and height within the building.

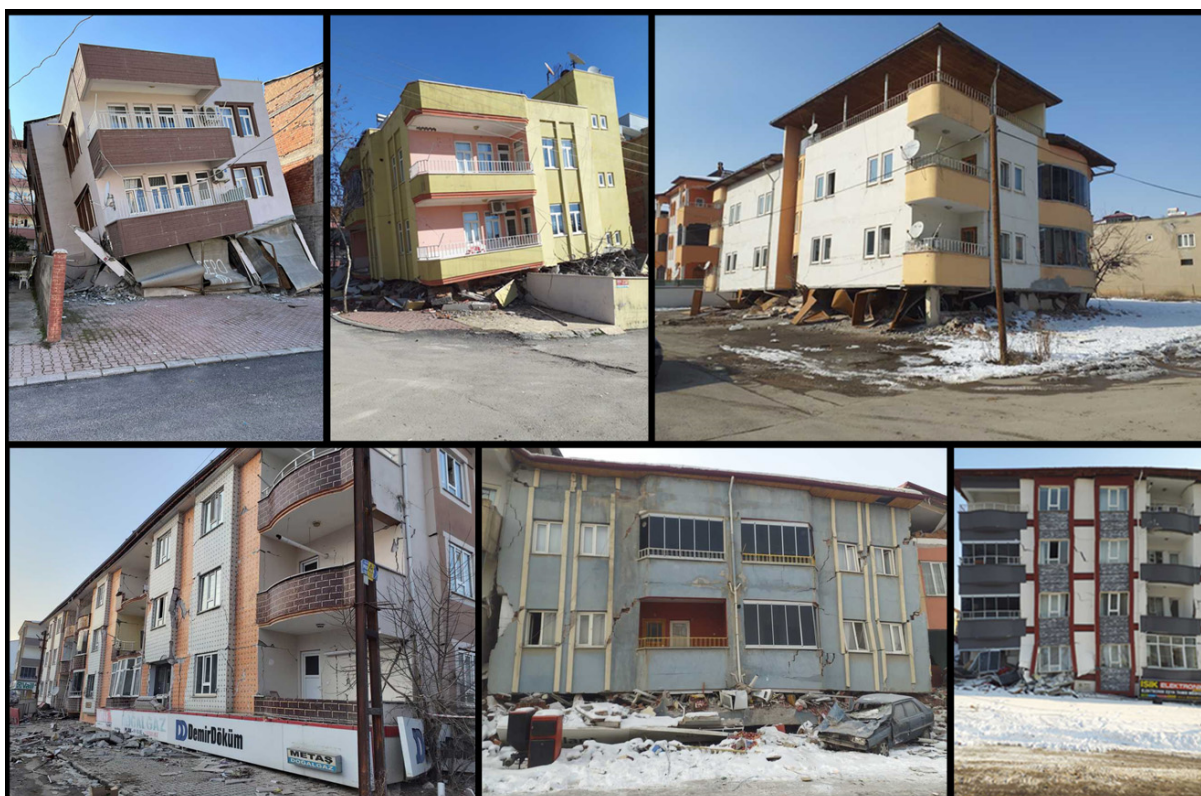
The cause of failure observed in most of the structures that were subjected to complete collapse in the earthquake zone was the soft story. In these buildings, especially those located on main streets, the ground floor is generally used as a commercial enterprise, while the upper floors are used for residential purposes. The amount of infill wall varies due to the change in purpose of use. In this case, complete collapse occurred as the upper floors of the building collapsed onto the soft story. Sample buildings that partially or totally collapsed and became unusable as a consequence of the soft ground story are shown in Figure 10.

Figure 10. Examples of buildings with partially or completely collapsed ground story due to soft stories.

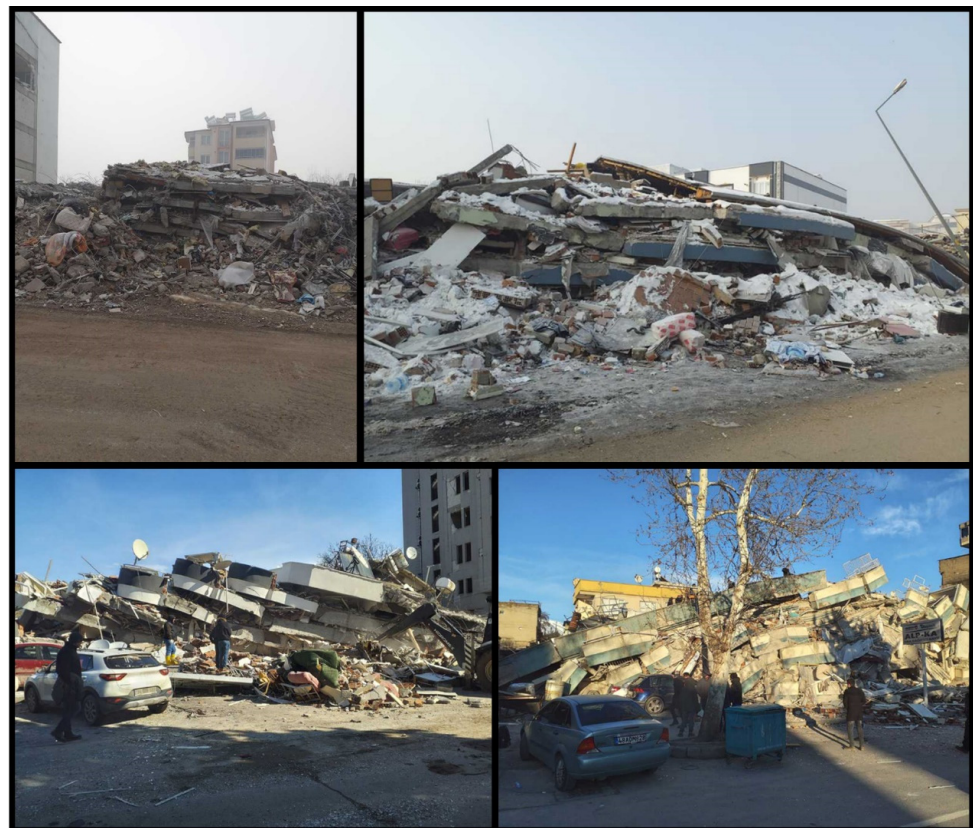
The pancake-type collapse was the type of damage observed during the Kahramanmaraş earthquakes, which caused the total collapse of the structure and made search and rescue efforts under the rubble the most difficult. This situation causes the upper floors of the buildings to collapse on the lower floors in an earthquake. When buildings could not absorb the energy caused by the earthquake, they were subjected to complete collapse. Insufficiently reinforced concrete, not using reinforced concrete shear walls, not ensuring continuity between load-bearing elements, and creating strong beams and weak columns can be counted among the causes of such damage. Sample images for pancake collapse are shown in Figure 11.

Figure 11. Examples of pancake-type collapse.

To prevent such collapses, a sufficient amount of reinforced concrete shear walls should be used in both directions to increase the rigidity of the structure, the criteria given in the earthquake regulations should be complied with for the columns to be stronger than the beams, and the ductility and continuity of the structural system members that form the reinforced concrete frames should be ensured to be sufficient.

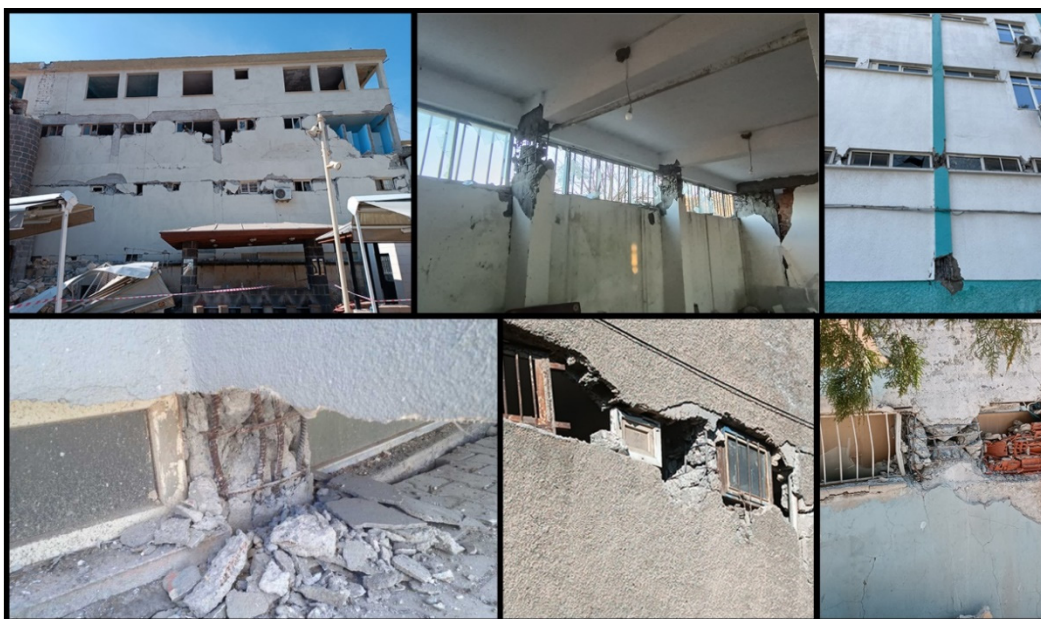
Another type of damage encountered in reinforced concrete structures after an earthquake is damage caused by short columns. Short column behavior is the brittle behavior of the reinforcing bars in the building element under the earthquake effect due to the shear force before reaching the yield level, causing collapse damage. Band windows, which are generally used in buildings, may produce short columns due to the change in column heights within the structure [78]. If the column net length (l_n) taken into account in the building design is smaller than the calculated value, the V_e shear force value increases, and, with the earthquake effect, more load is loaded than the V_e shear force value calculated for the column. In this case, short column damage is encountered. In cases where the formation of short columns cannot be prevented, the shear force is to be taken as the basis in the calculation of transverse reinforcement;

Figure 13. Examples of short column damage.

In short column design, minimum transverse reinforcement and placement conditions defined for confined boundary regions must be applied throughout the entire column. If the infill walls are completely adjacent to the columns, transverse reinforcement will be continued throughout the entire floor height for the columns that work as short columns (Figure 12).

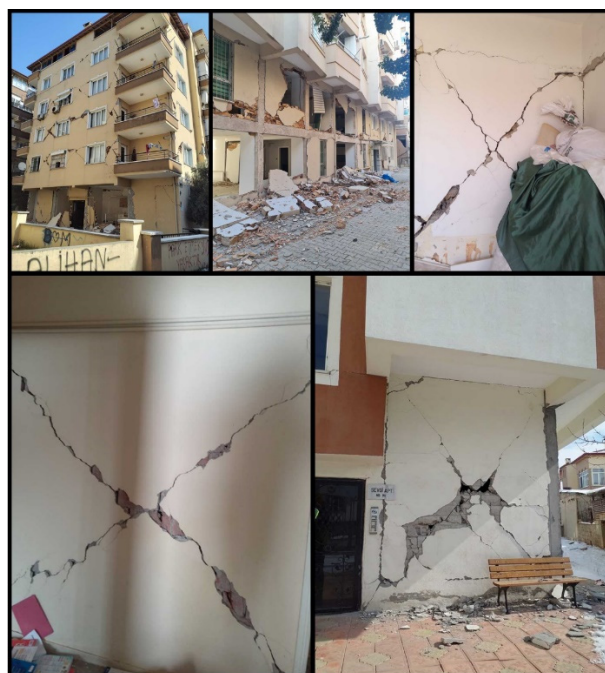
Various levels of damage have also occurred in the infill walls used to delimit and separate spaces in reinforced concrete structures. In general, the low mechanical properties of wall materials, which are given an aesthetic appearance by using gypsum plaster without the use of lime–cement plaster, as well as poor masonry work, have negatively affected the structural damage occurring in these elements. Some examples of damage encountered in infill walls are shown in Figure 14. This damage was generally observed as shear cracks and out-of-plane failure.

Figure 14. Examples of infill wall damage because of the Kahramanmaraş earthquakes.

To prevent infill wall damage, rough plaster must be used and appropriate wall material and masonry must be provided. In addition, the mortar used on the walls must be applied in a way that provides sufficient interlocking. Failure to adequately clamp the

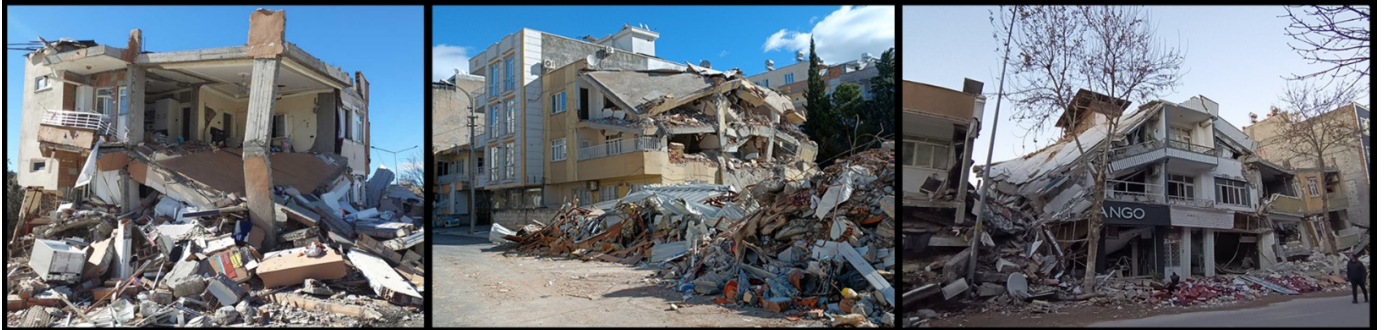
slabs used in reinforced concrete structures to the beam and column members to which they are connected, and failure to ensure full continuity between the elements, causes the slabs to separate from these structural members and be damaged. Samples of such failure are shown in Figure 15.

Figure 15. Damage caused by inadequate slab–beam–column connection.

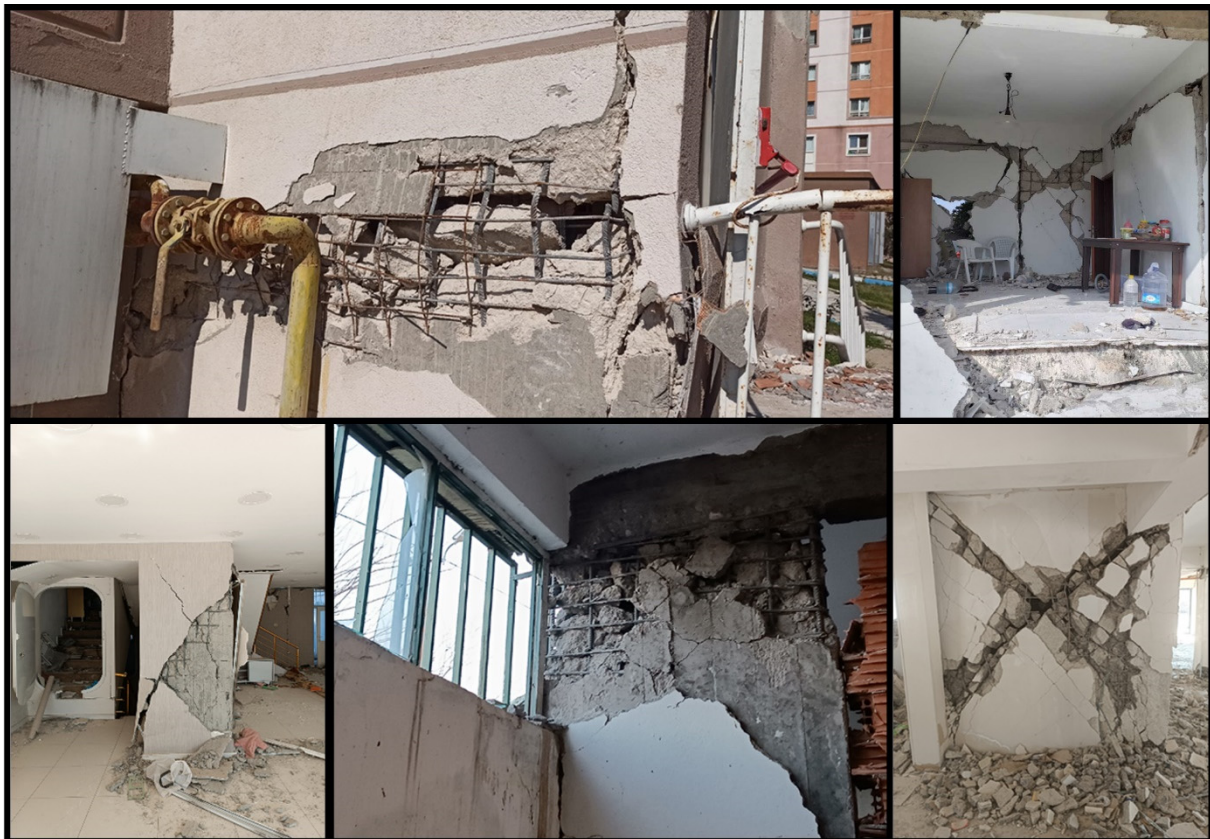
The construction of shear walls in reinforced concrete structures without complying with earthquake-resistant structure design principles caused the load bearing capacity to be exceeded in these members and led to structural damage at different levels. In particular, failure to form shear wall boundary zones, excessive transverse reinforcement spacing, and use of low-strength concrete increased the extent of damage to wall elements. Examples of shear wall damage are shown in Figure 16.

Figure 16. RC shear wall damages.

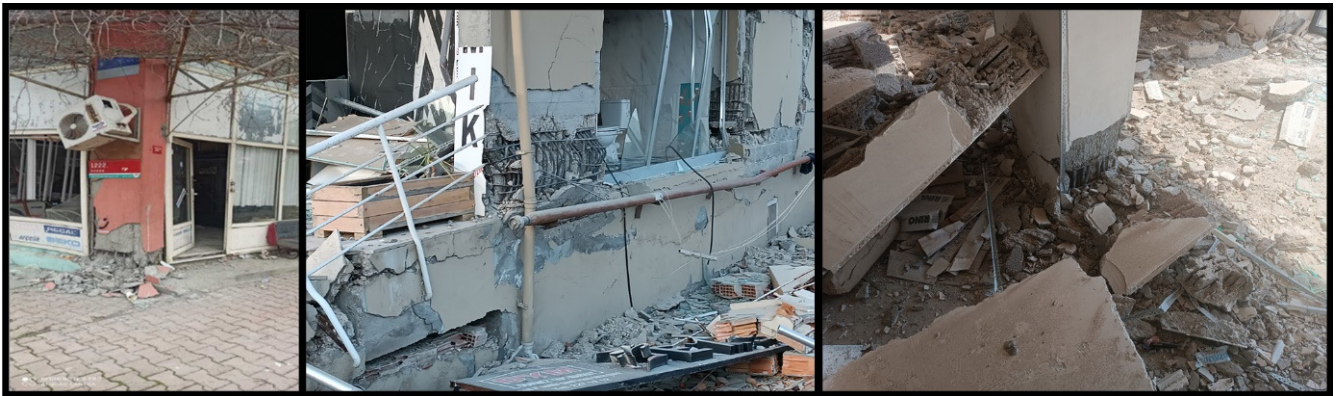
During an earthquake, plastic hinges are desired to form in beams, not columns. In some buildings, beams have larger cross-sections, higher strength, and are more rigid than columns. This case causes the columns to be exposed to large shear forces, causing brittle failures, and then complete collapse may occur. Examples of plastic hinge damage occurring at the lower and upper-end points of the column are shown in Figures 18 and 19, respectively. Plastic hinge damages occurring at the upper ends of the column due to the cantilever beam effect are also illustrated in Figure 20.

Figure 18. Examples of the plastic hinge damage at the lower end of the column.

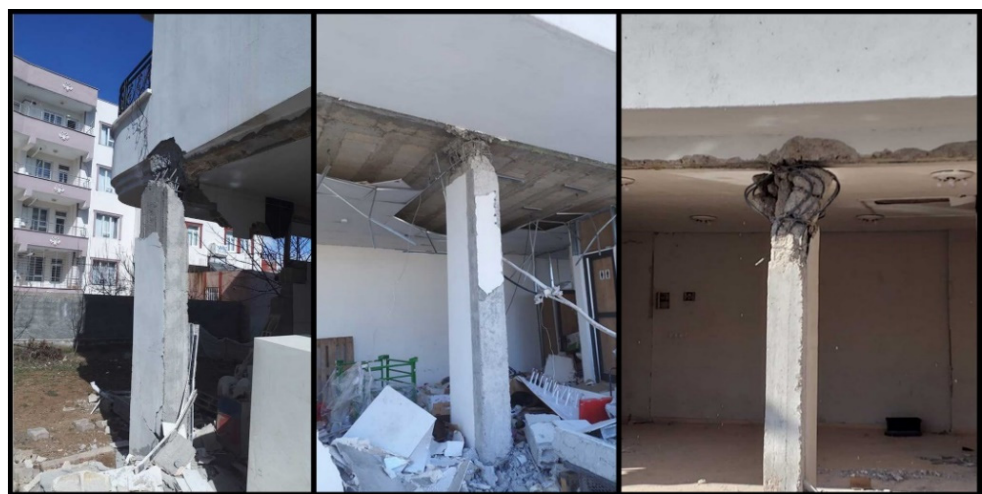
Figure 19. Examples of the plastic hinge damage at the upper end of the column.

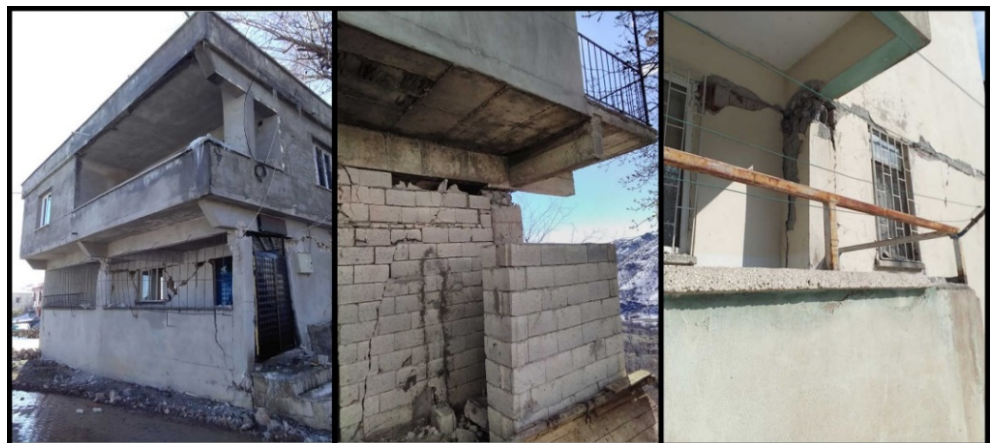
Figure 20. Examples of the plastic hinge damage due to the cantilever beam effect.

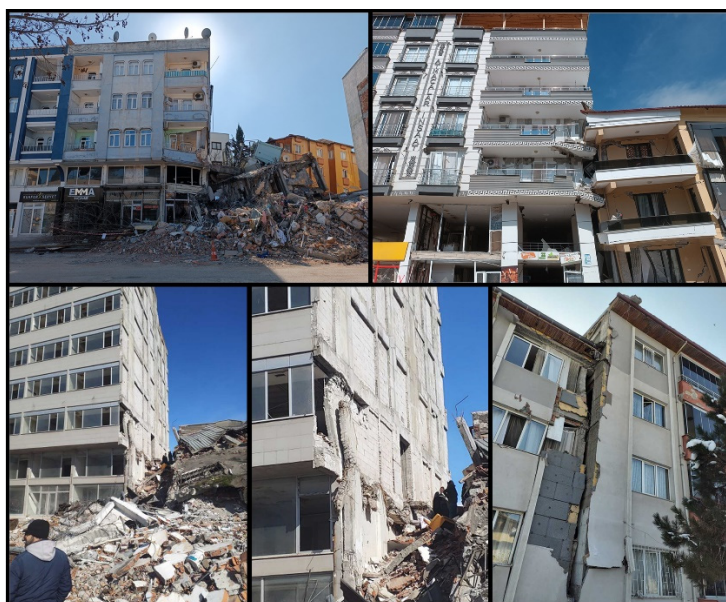
In adjacent reinforced concrete structures without sufficient gap, additional shear forces occur in the neighboring structures due to the pounding effect. In this case, as a result of exceeding the shear force capacity of the RC columns, significant damage occurs at different levels in adjacent buildings. Structural damage caused by the pounding effect is illustrated in Figure 21.

Figure 21. Structural failures caused by the pounding effect.

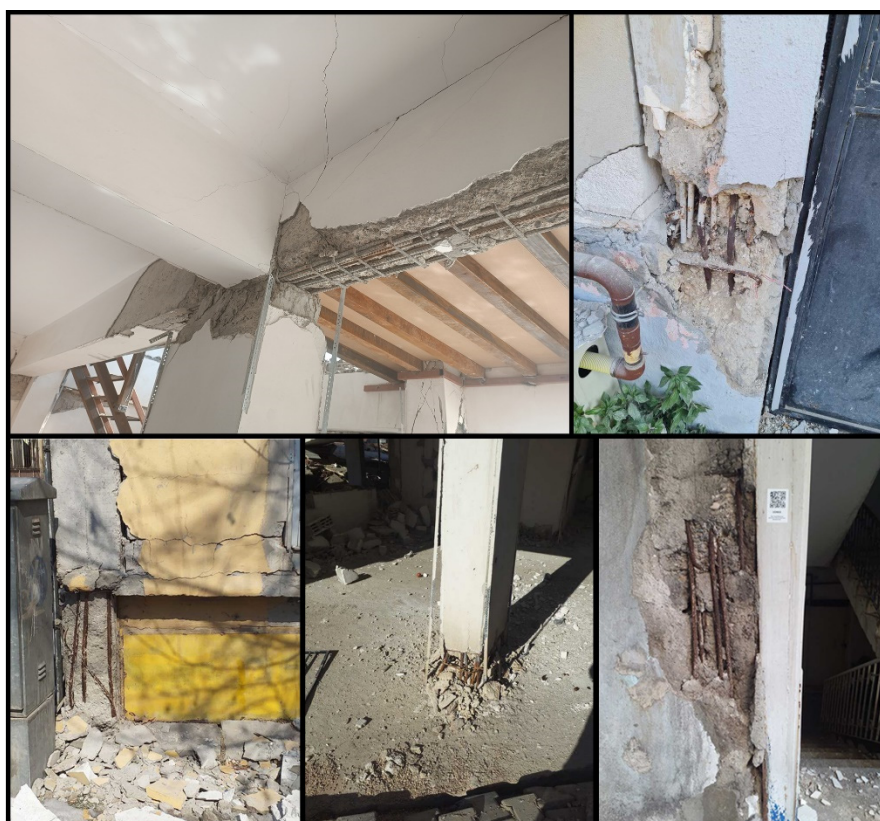
Concrete cover, which is a part of the reinforced concrete structural element, is used to protect the reinforcement used in reinforced concrete bearing members from external effects. This section, not made of sufficient thickness, corrodes over time, causing both the bearing capacity to decrease and the cross-sectional area to decrease, causing crushing damage to the concrete in this area. Rusting and resulting structural damage due to insufficient concrete cover thickness are shown in Figure 22.

Figure 22. Examples of buildings with insufficient concrete cover.

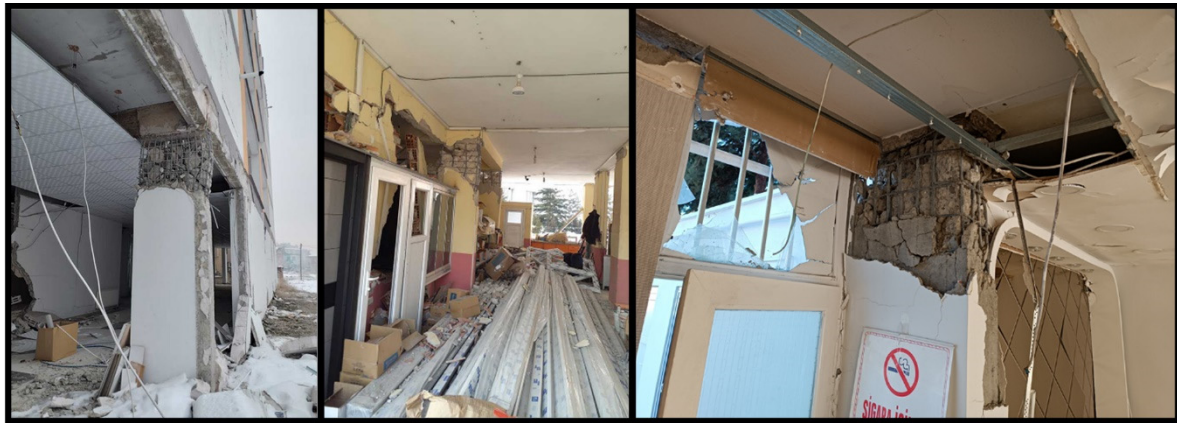
One of the roles expected from transverse reinforcement is to reduce the brittle feature of the core concrete. Transverse reinforcements fulfill this function by confining the core concrete. Insufficient adherence between concrete with reinforcement and low-strength concrete caused the core concrete to be completely crushed. Examples of such structural damage are illustrated in Figure 23.

Figure 23. Structural failures caused by the crushing of core concrete in columns.

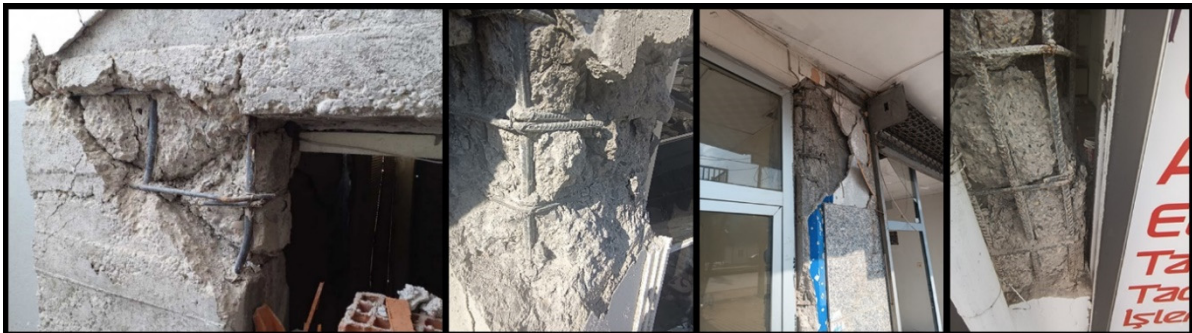
For the stirrups or cross-ties to be used in the columns to interlock for the longitudinal reinforcement, the connection must be made at an angle of 135° . This stipulation is necessary for adequate interlocking between transverse and longitudinal reinforcement. Otherwise, the transverse reinforcement will separate from the longitudinal reinforcement and have problems in performing its roles. This also negatively affects the adherence between transverse reinforcement and concrete. Damage caused by such misuse is shown in Figure 24.

Figure 24. Structural failures caused by application fault of stirrups.

The stirrups end commonly have 90° hooks and do not overlap in damaged columns in the earthquake region. It is specified that closed stirrups with 135° hooks are used, and the stirrups interlock into the core concrete in Turkish Standards. Correct and incorrect applications of the stirrup according to the Turkish standard are illustrated in Figure 25.

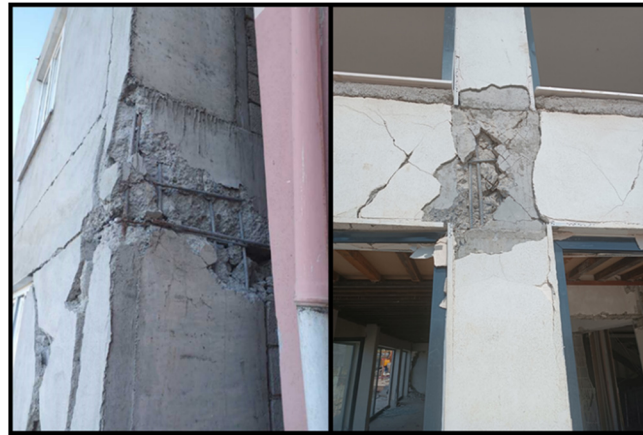
Another cause of damage is crushing damage to the concrete as a result of not using sufficient reinforcement in the column–beam connection. Failure to pay due attention to

the embedment and addition of reinforcement, which was not used in sufficient quantities, caused damage in these areas, and examples of such failure are shown in Figure 26.

Figure 26. RC building damage caused by insufficient reinforcement in the column–beam joint.

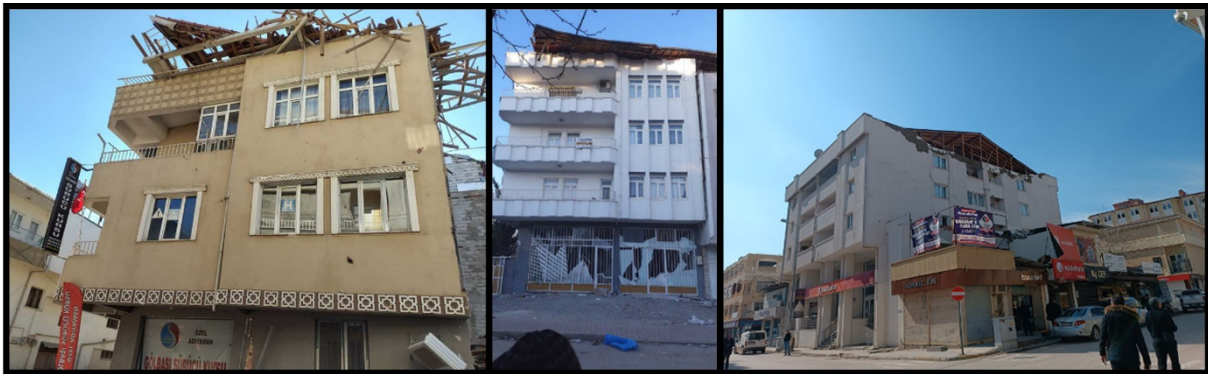
Wooden roofs used in reinforced concrete structures and gable walls on the roofs are other parts that are damaged during earthquakes. Such observed failures are shown in Figure 28.

Figure 28. Samples of roof gable wall failure and collapsed roof.

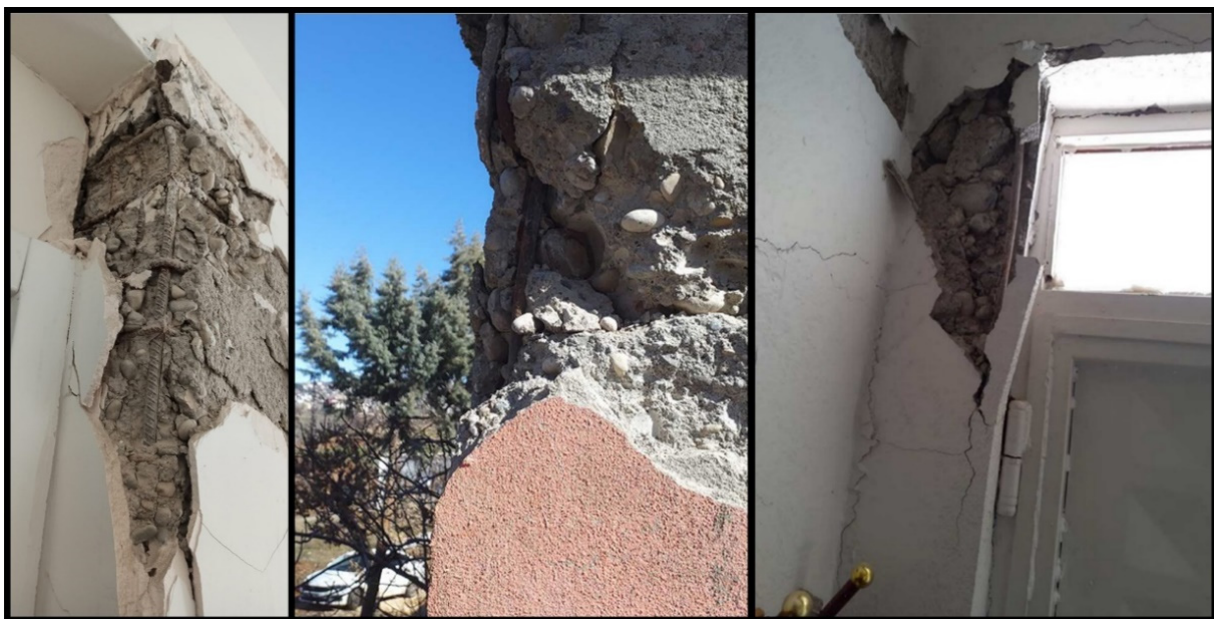
Inappropriate aggregate granulometry and usage of the stream aggregate directly affect the concrete strength in RC structures. The different levels of damage that occur in the structural elements due to improper aggregate grain distribution, placement of concrete, compaction, and lack of care during maintenance stages are shown in Figure 29. Failure to use appropriately sized aggregate negatively affects both the adherence of the aggregate within itself and the adherence to the reinforcement.

Figure 29. Examples of structural damage resulting from improper aggregate granulometry.

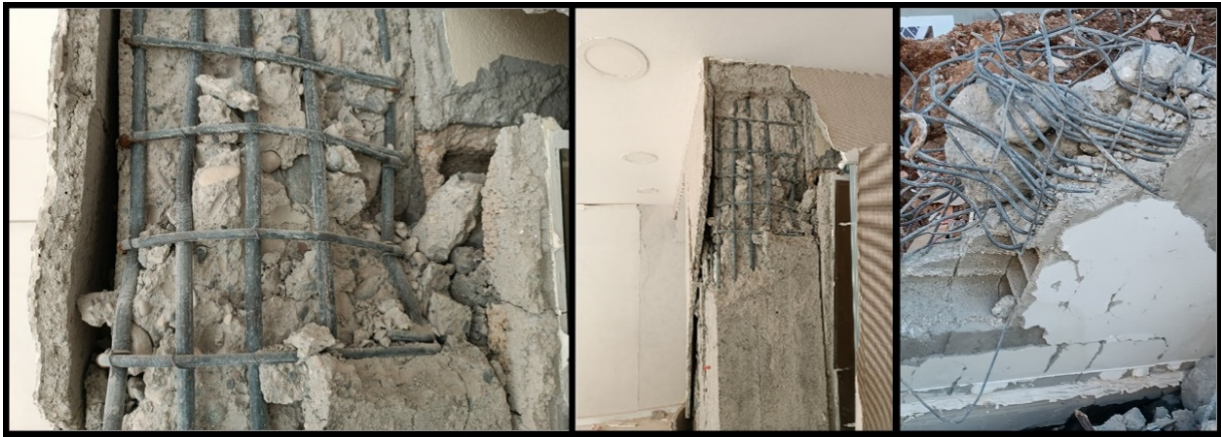
The reinforcements used in many structures that were heavily damaged in the earthquake zone are plain reinforcements. Both the bearing capacity and the adherence between plain reinforcement and concrete are much lower than in ribbed reinforcement. Examples of damage resulting from this are shown in Figure 30.

Figure 30. Examples of damaged structures using flat reinforcement.

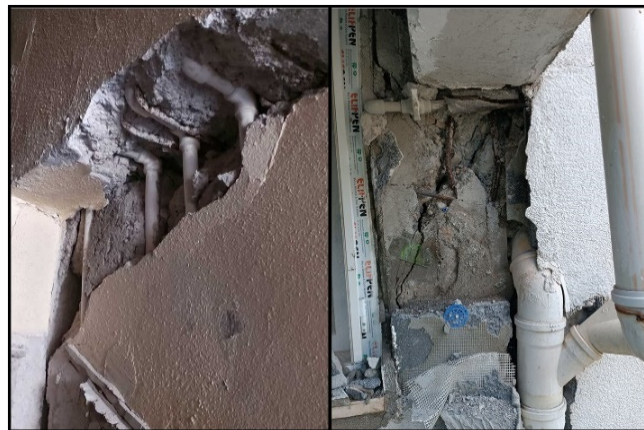
Figure 31. Examples of installations passing through structural system elements.

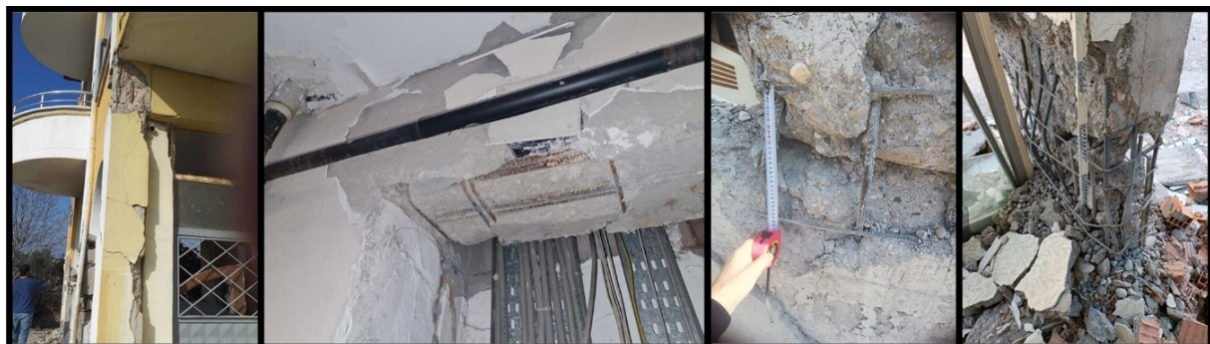
The main function of stirrups or cross-ties used in reinforced concrete columns and beams is to resist the shear forces that occur. Reinforcement strength, diameter, spacing, and concrete strength directly affect the shear force capacity. In addition, there must be dimensional harmony between the longitudinal reinforcement diameter and the transverse reinforcement diameter. Otherwise, the transverse reinforcement may be separated from the longitudinal reinforcement and stripped. Examples of damage caused by inadequate transverse reinforcement are illustrated in Figure 32.

Figure 32. Structural failures caused by insufficient transverse reinforcement.

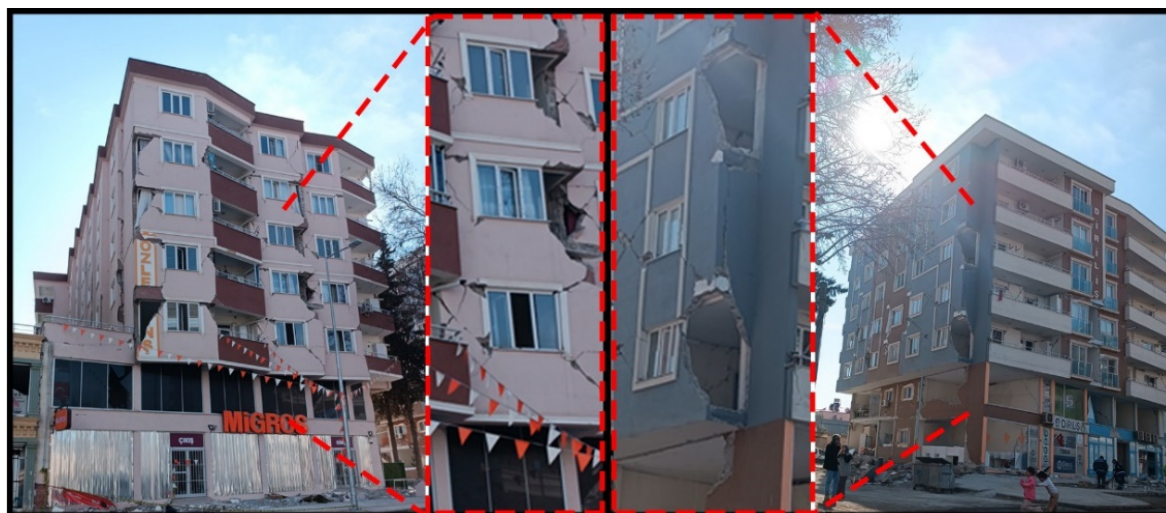
In some R/C structures, heavy overhangs are built on the floors above the ground floor to increase the usage area. There have been parts of the commonly used heavy overhangs, that extend beyond the R/C frame, which were damaged during the earthquake. Samples of structural failure at different levels in heavy overhangs are illustrated in Figure 33.

Figure 33. Examples of the structural damage caused by heavy overhangs.
