Comparative Analysis of Target Displacements in RC Buildings for 2023 Türkiye Earthquakes

Abstract: The Kahramanmaraş (Türkiye) earthquake on 6 February 2023, one of the largest earthquakes of the century, caused the collapse or severe damage of thousands of structures. This catastrophic disaster resulted in over 53,000 fatalities and rendered many structures unusable. This study addresses the observed damage in reinforced concrete (RC) structures, which constituted the majority of the existing urban building stock. In this study, firstly, information about the destructive Kahramanmaraş earthquakes was given. The predicted PGAs in the last two earthquake hazard maps used in Türkiye were compared with the measured PGAs from actual earthquakes to determine whether the earthquake hazard is adequately represented for eleven affected provinces in the earthquake region. The damages in RC structures were evaluated within the scope of civil and earthquake engineering. Structural analyses for the model created to represent mid-rise RC buildings in the region were carried out separately for each province using predicted and measured PGAs. Additionally, target displacements that were used in

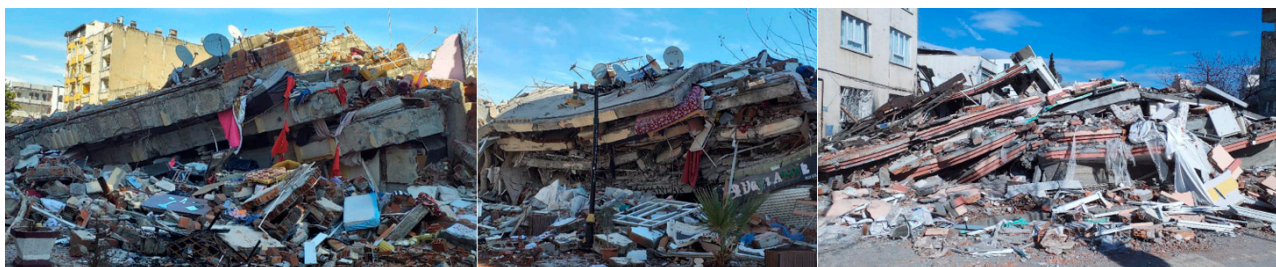
Figure 5. Examples of totally collapsed RC structures.

In the eleven provincial centers most affected by the Kahramanmaraş earthquakes, significant and varied structural damage occurred in different structural systems. While the dominant building stock in rural areas is masonry structures, the dominant building stock in urban areas is RC structures. In this section, the damage examples commonly observed in RC structures of the urban dominant building stock are examined in terms of civil and earthquake engineering. In particular, the damage examples in RC structures from the three provinces affected by the earthquake, Hatay, Kahramanmaraş, and Adıyaman, are taken into consideration. The causes of the damages and their schematic representations are made for better understanding. In this way, the main causes of the damages can be better revealed. Irregularities and weaknesses in RC structures played an active role in the damages. The magnitude of the earthquakes that occurred on the same day and the local ground conditions also directly affected the level of damage. As a result of earthquakes, there was great destruction in RC structures. Examples of RC structures that reached a total collapse mechanism are shown in Figure 5.

Insufficient interlocking between load-bearing elements in RC structures, strong beam-weak column formations, and weak material properties prevented the RC frame from functioning as a whole. For these reasons, the floors in the building collapsed on top of each other. Such collapses are the ones that make after-earthquake search and rescue efforts most difficult.

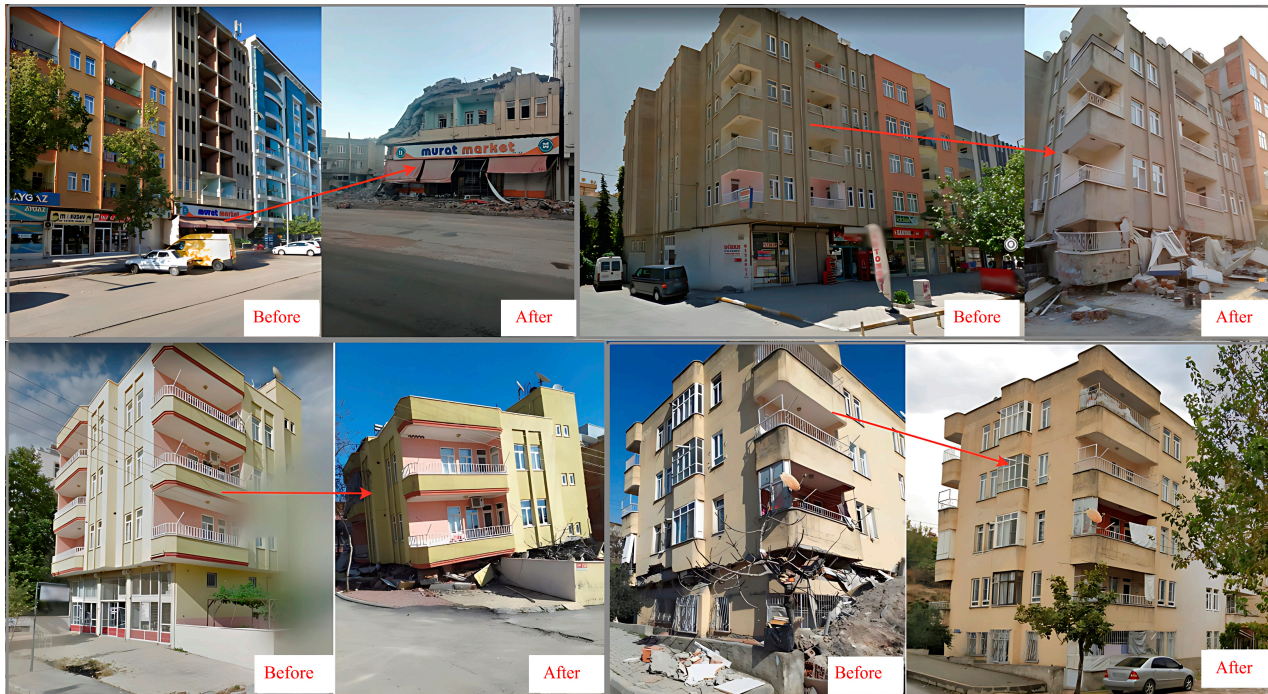
Figure 6. Comparison of some RC building examples before and after the earthquake.

In order to understand the destructive impact of earthquakes, a comparison of the building conditions of four sample RC buildings before and after the earthquake is illustrated in Figure 6. The difference in strength and stiffness between stories caused partial or total collapse of the intermediate or ground floors. In such demolitions, it is not possible to strengthen and reuse the structure.

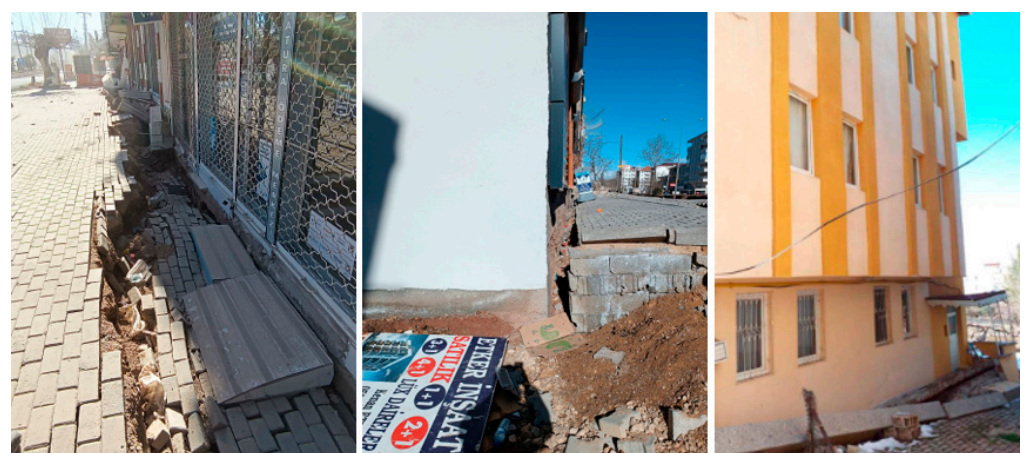
Figure 7. Soil liquefaction samples in the earthquake region.

Soil liquefaction is the temporary liquefaction of the soil due to the increase in water pressure between the soil particles as a result of strong vibrations such as earthquakes. This situation can cause damage at different levels by causing the bearing capacity of the soil structure to decrease significantly [81–83]. Examples of such damage are shown in Figure 7.

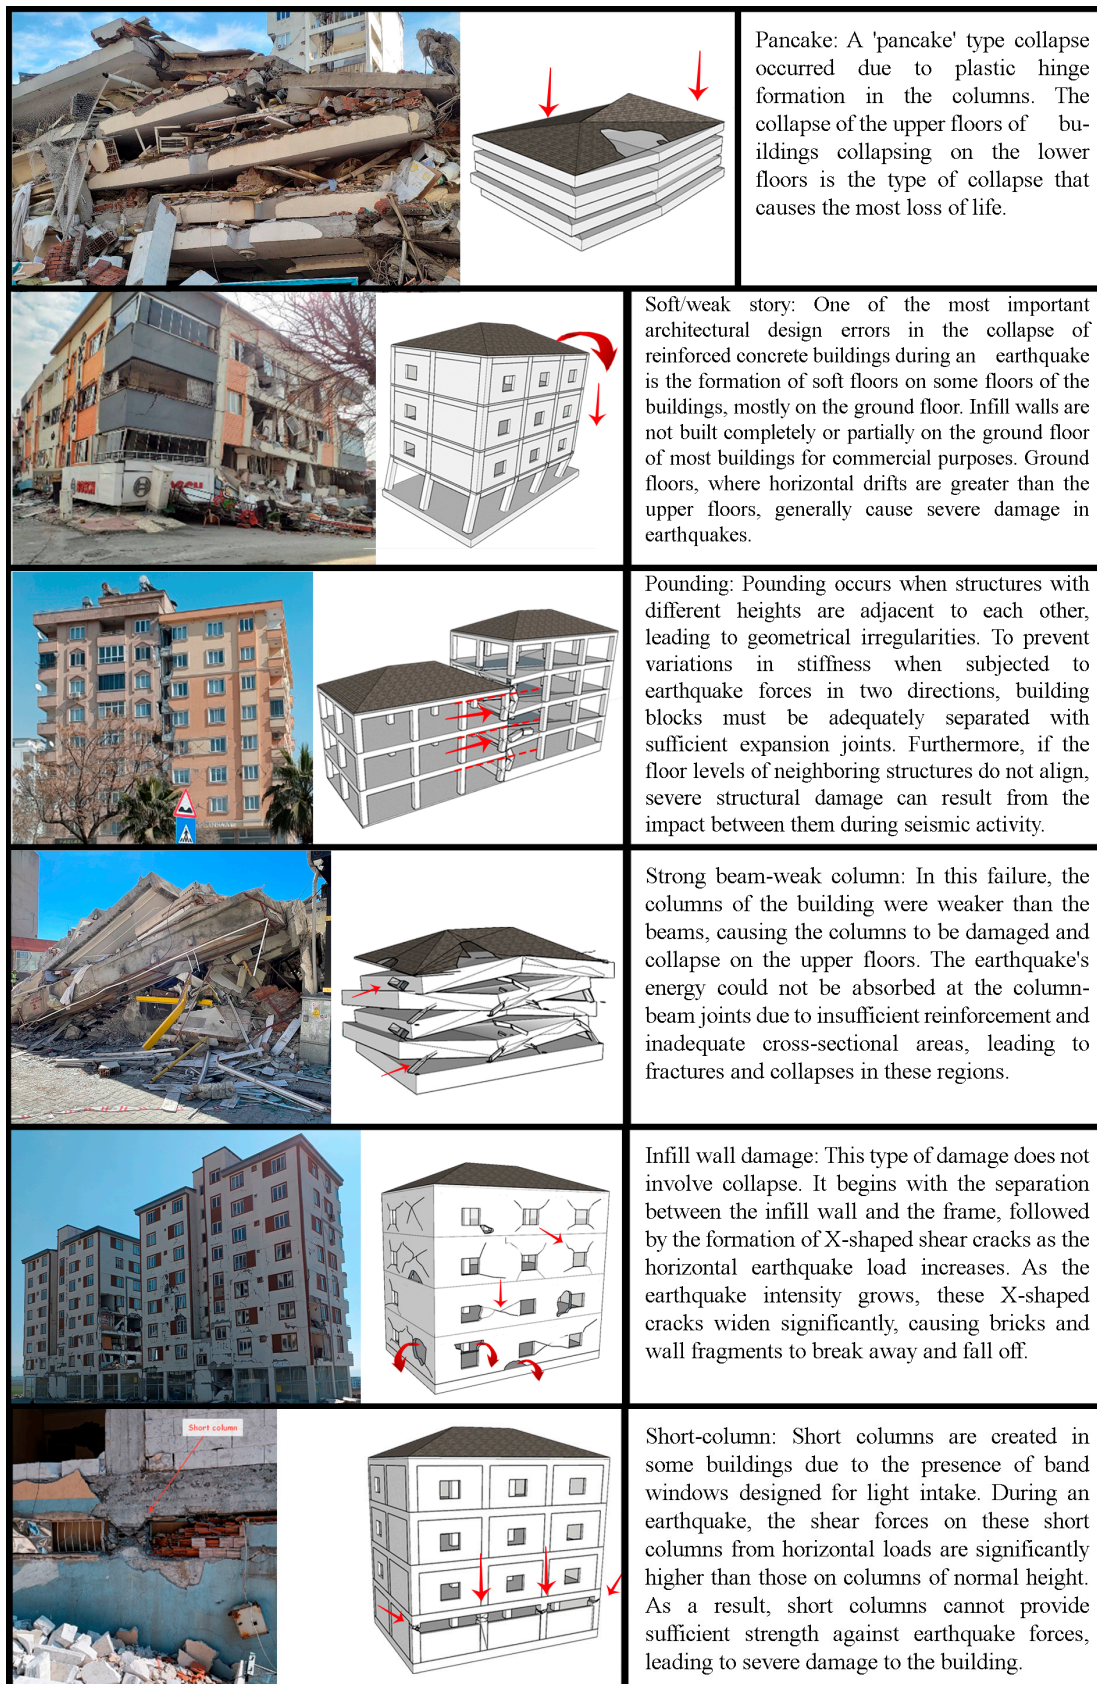
Figure 8. Cont.

This study provides information on the damages commonly encountered in RC structures and their causes based on field observations. In particular, the lack of, or complete failure to apply, earthquake-resistant structural design principles has increased the extent of damage in RC structures. Examples of structural damage in RC buildings, their causes,

and their schematic representations, which are commonly encountered in the earthquake region, are given in Figure 8.

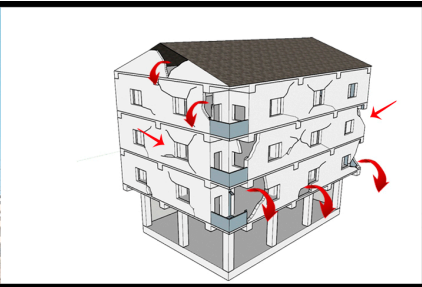
| | | <p>Heavy overhang: Heavy overhangs are one of the factors that cause vertical structural irregularities. These overhangs, added to expand the upper floor's usage area, exhibited negative performance during the earthquake, leading to various levels of damage in many buildings.</p> |

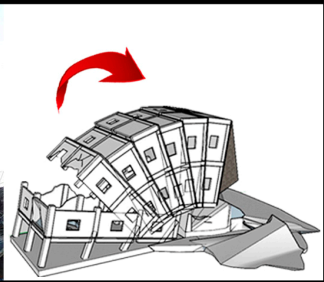
| | | <p>Lateral collapse: Although the frame system of the building remains intact, many buildings collapsed laterally due to ground and foundation failures.</p> |

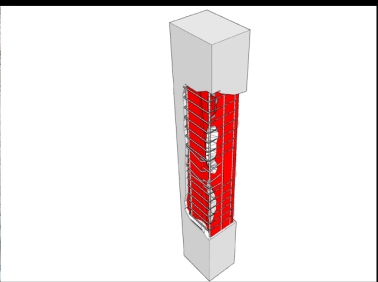
| | | <p>90° hooks instead of 135°: The ends of the stirrups and cross-ties must be fully hooked (135° bent). In the structure, the type of damage caused by the yielding in the vertical reinforcement, the excessive spacing of the stirrups, and the ends of the stirrups being open outside without bending 135° towards the inside of the column are observed.</p> |

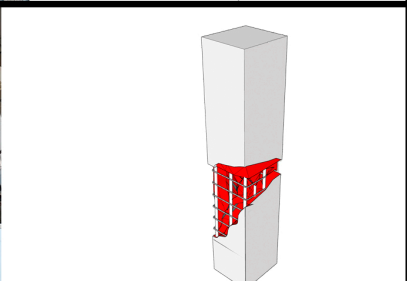
| | | <p>Usage of plain reinforcement: Plain rebar used in many older buildings has been found to cause significant structural damage due to its poor adhesion to concrete. Following the 1998 regulation in Türkiye, the use of ribbed reinforcement became mandatory.</p> |

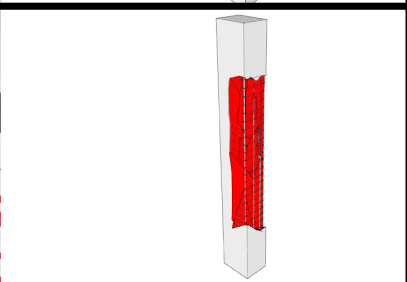
| | | <p>Inadequate concrete cover: The concrete cover, which increases the durability of reinforced concrete by protecting the reinforcement steel from corrosion, is left at 2.5 cm in normal cases, 4 cm in external members, and more in water structures. Due to the insufficient concrete cover thickness, the concrete coating breaks and falls, causing structural damage to the column.</p> |

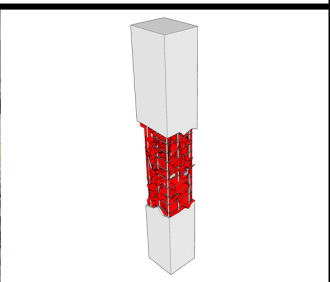
| | | <p>Low-strength concrete: Due to the shear effect of the earthquake, cracking and disintegration occurred at lower load levels. Under this load, the column reinforcement separated from the fractured concrete, leading to structural damage.</p> |
