# Failures in Reinforced-Concrete Columns and Proposals for Reinforcement Solutions: Insights from the 2023 Kahramanmaraş Earthquakes

**Abstract:** Türkiye, a country that suffers significant structural damage from earthquakes, was struck by two major quakes on 6 February 2023, centered in Pazarcık ( $M_w = 7.7$ ) and Elbistan ( $M_w = 7.6$ ) in Kahramanmaraş. These earthquakes caused extensive damage and destruction to urban concrete structures, significantly contributing to the loss of life. Inadequate designs in columns, which are meant to maintain structural integrity and transfer forces, were a primary cause of the structural damage. This study provides information about these catastrophic earthquakes, focusing on the detailed examination of damages in reinforced-concrete (RC) columns. Structural analyses were conducted on a selected RC building, taking into account the primary causes of column damage: low-strength concrete and insufficient transverse reinforcement. Five different concrete classes and two transverse reinforcement spacing options were considered to analyze the impact of concrete strength. To address the exceeded shear forces in the columns, a fiber-reinforced

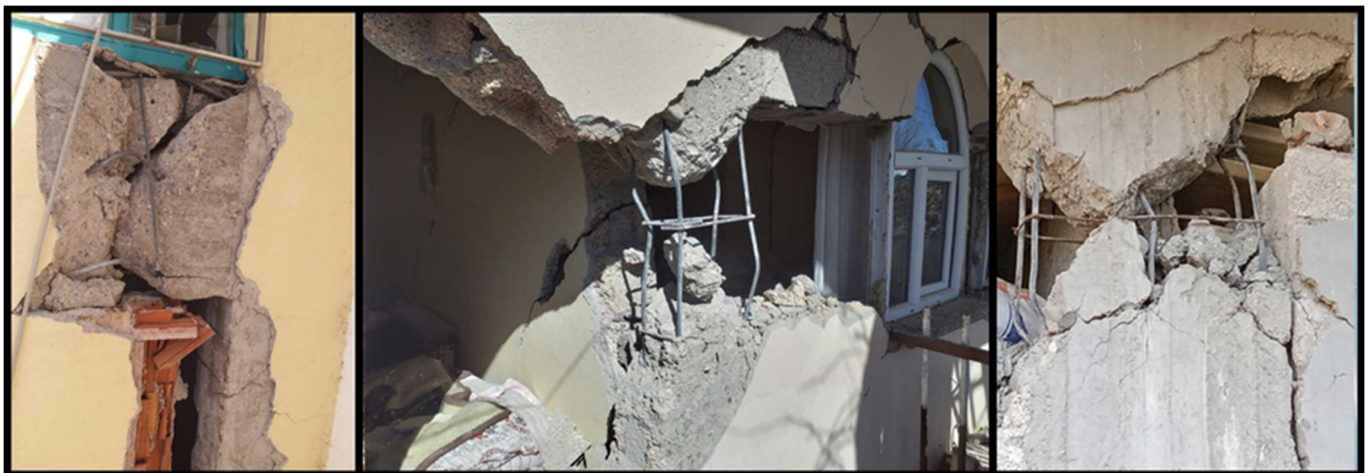
Investigations conducted after the earthquakes revealed that buildings with different structural systems experienced collapse and varying levels of damage. In reinforced concrete columns, particularly insufficient transverse reinforcement spacing led to different degrees of damage. The transverse reinforcement used in reinforced concrete structures can wrap around the core concrete, reducing the brittle nature of the concrete. This, in turn, enhances the strength of the concrete and increases the ductility capacity of the element. Additionally, one of the expected functions of transverse reinforcement is to help resist shear forces alongside the concrete, reduce the buckling length of longitudinal reinforcement to prevent potential buckling, and keep the longitudinal reinforcement in place during concrete placement. The use of inadequate transverse reinforcement negatively affects many of these expected functions. Examples of damage caused by insufficient transverse reinforcement are shown in Figure 2.

**Figure 2.** Examples of damage caused by insufficient transverse reinforcement.

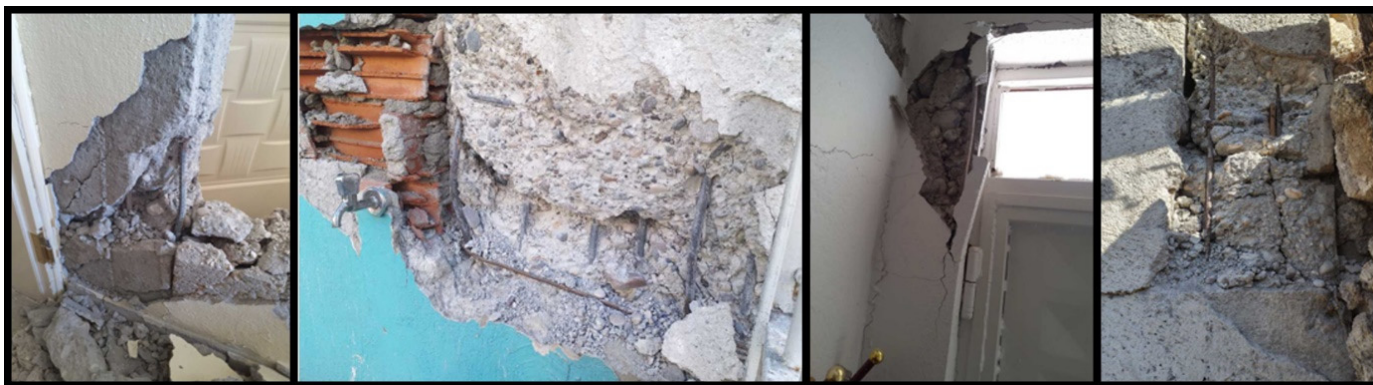
The low strength of the concrete used in reinforced concrete columns has led to varying levels of structural damage. This low concrete strength is generally due to factors such as the use of non-graded aggregates, insufficient dosage, inadequate mixing, lack of compaction, and insufficient curing. Examples of damage caused by low-strength concrete are shown in Figure 3.

**Figure 3.** Examples of damage from low-strength concrete.

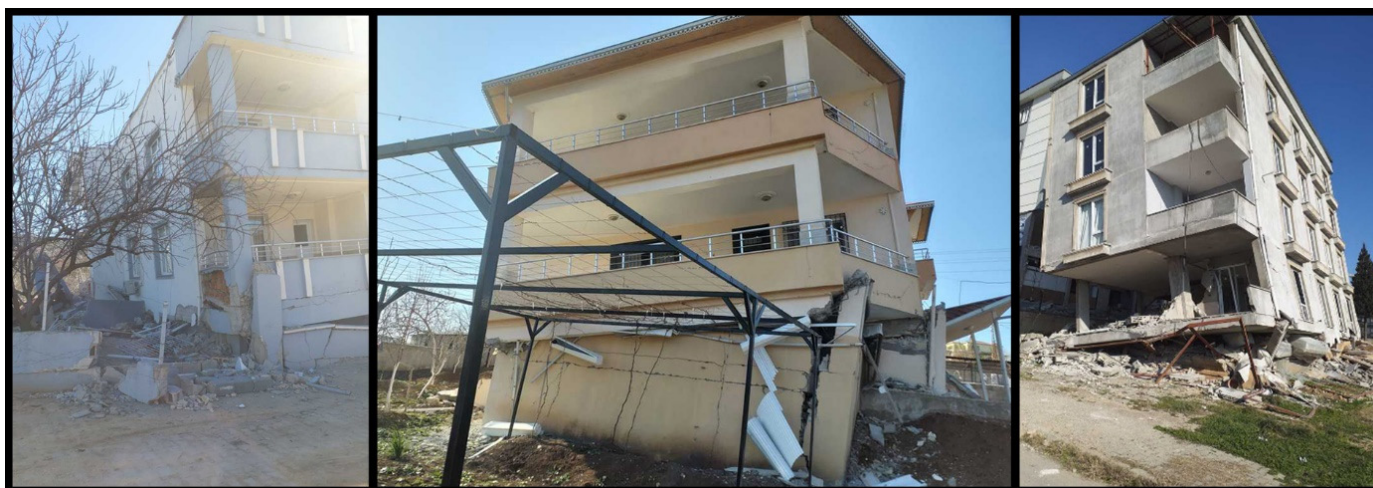
Due to the shear forces acting on reinforced concrete structures, the lateral displacement of the columns on the ground floor can lead to a collapse mechanism in the structural system. As shown in Figure 4, lateral displacement caused by shear forces can be observed in the lower columns.

**Figure 4.** Examples of out-of-plane damage in columns.

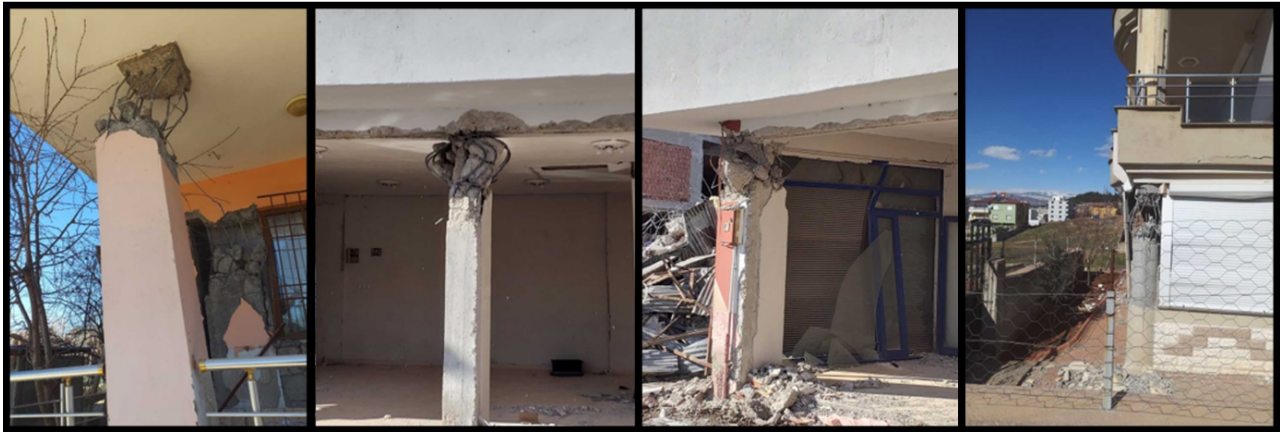
One of the common types of damage observed in reinforced concrete columns is buckling damage, which occurs in cases where the stirrups are sparse at the ends of the columns. This is because the buckling of the reinforcement can lead to the disintegration of the upper part of the column and shortening under axial load. The resulting changes in the dimensions of the column lead to a different redistribution of forces. For this reason, transverse reinforcement is tightened in the end regions of the columns. In areas where plastic hinges may form, the tightening of the stirrups increases the ductility and strength of the column. The transverse reinforcements used in the design of reinforced concrete elements help shorten the buckling lengths of the longitudinal reinforcements. Examples of plastic hinging that occur at the upper ends of columns due to insufficient transverse reinforcement are shown in Figure 5.

**Figure 5.** Plastic hinges occur in the upper-end regions of the column.

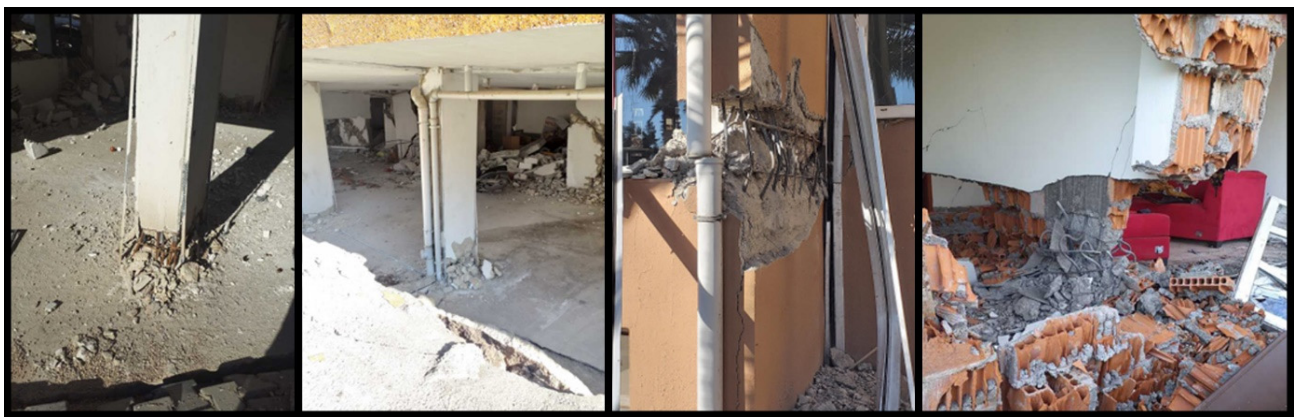
Plastic hinges have also been observed in the lower-end regions of the columns for the same reasons as in the upper regions. Examples of this type of damage in the lower-end regions are shown in Figure 6.

**Figure 6.** Plastic hinges occur in the lower-end regions of the columns.

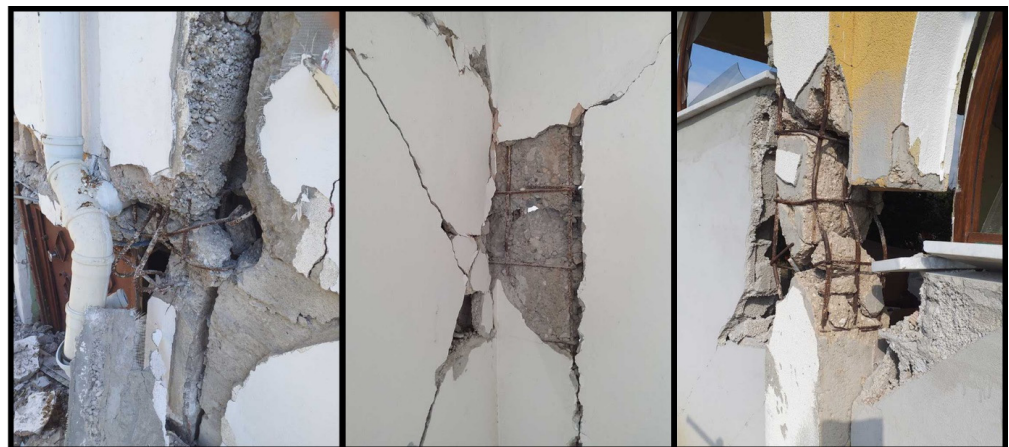
One of the factors affecting the load-bearing capacity of columns is inadequate concrete cover thickness. Insufficient concrete cover over time leads to the corrosion of the reinforcement and a reduction in the reinforcement area, resulting in a decreased load-bearing capacity. Examples of columns that have been damaged due to corrosion from insufficient concrete cover thickness are shown in Figure 7.

**Figure 7.** Corroded reinforcement due to insufficient concrete cover thickness and inadequate anchorage.

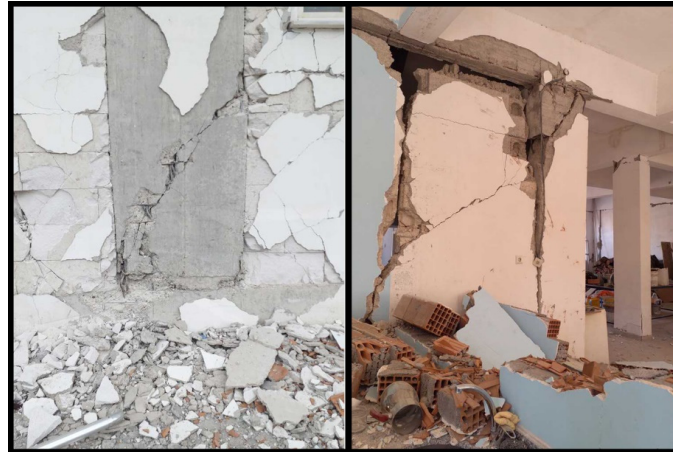
Tensile cracks in columns form at an angle to the beam axis. If the shear reinforcement is insufficient, the width of the cracks will be larger. Shear cracks and the subsequent

shear failure are undesirable conditions, as they represent a brittle type of failure; examples of a shear crack are shown in Figure 8. If the shear capacity of the columns is inadequate—meaning that sufficient stirrup tightening and details such as the lengths of the reinforcement laps have not been properly addressed—such damage has been observed. In this case, inclined shear cracks at approximately  $45^\circ$  occur in the column, as shown in Figure 8. If there is insufficient stirrup reinforcement in the columns, inclined shear cracks can lead to brittle failure.

**Figure 8.** Examples of a shear crack.

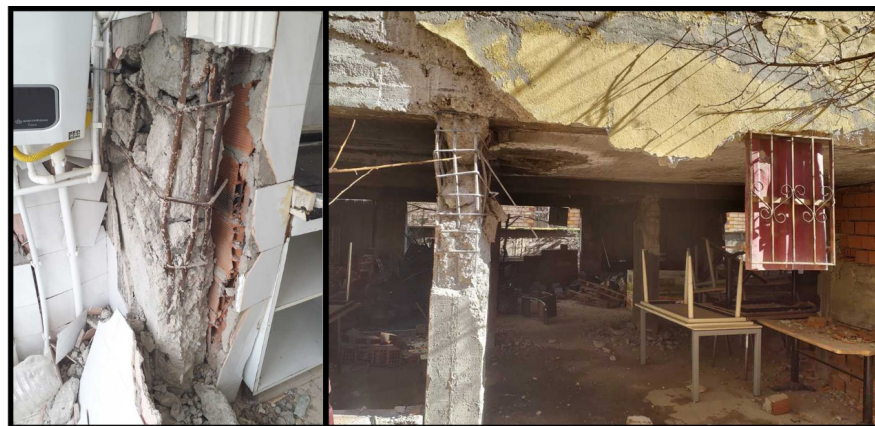
For transverse reinforcements to work effectively during an earthquake, it is recommended that the hook lengths are sufficient and the hook angles are bent at  $135^\circ$ . However, in practice, bending them at  $90^\circ$  causes the transverse reinforcements to not anchor sufficiently to the longitudinal reinforcements, resulting in easier slippage of the transverse reinforcements from the longitudinal ones. Examples of this type of damage are shown in Figure 9.

**Figure 9.** Slippage of reinforcements bent at  $90^\circ$  from the longitudinal reinforcements.

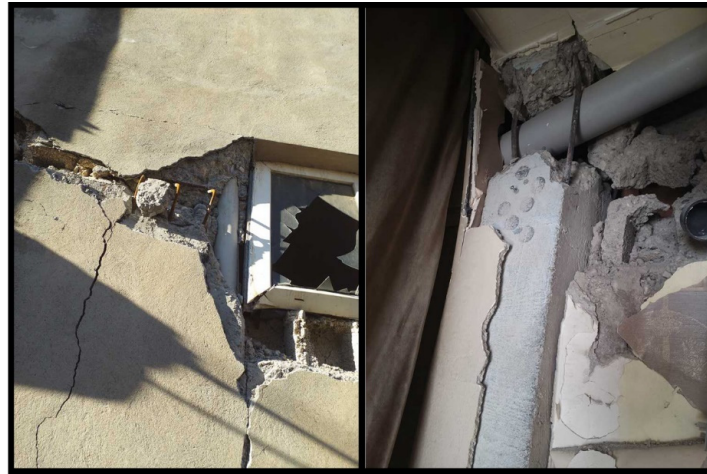
Different installation components passing through the structural system reduce the concrete cross-sectional area. As a result, this can lead to a decrease in the load-bearing capacity of the element. Examples of various installation components passing through a column are shown in Figure 10.

**Figure 10.** Examples of installations passing through the structural members.

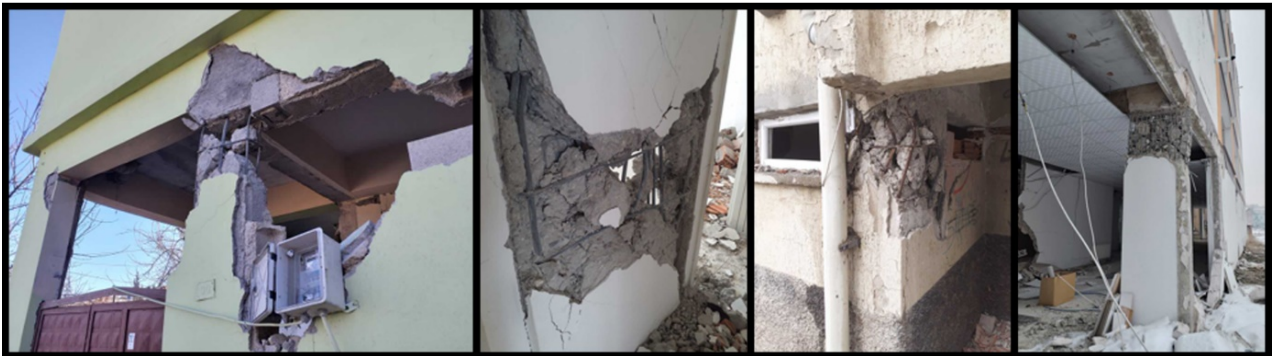
The spalling of core concrete in reinforced concrete columns is generally considered a significant issue affecting the durability of the structure. The spalling of core concrete can result from improper mix ratios, insufficient compaction, excessive loads, chemical effects, and similar factors. Additionally, inadequate transverse reinforcement used to reduce the

brittle characteristics of the core concrete can also contribute to this condition. Examples of this type of damage are shown in Figure 11.

**Figure 11.** Spalling of core concrete in columns.

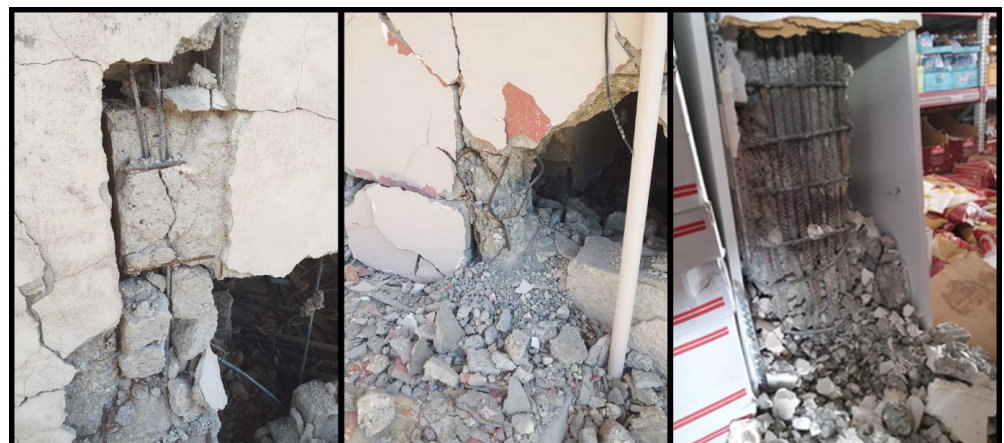
Reinforcement workmanship is a significant factor in the performance of the expected functions of the reinforcements in reinforced concrete columns. Due to the altered position and arrangement of the reinforcements, the load-bearing capacities of the structural elements can be exceeded, leading to damage. Examples of damage resulting from poor reinforcement workmanship are illustrated in Figure 12.

**Figure 12.** Examples of damage resulting from poor reinforcement workmanship.

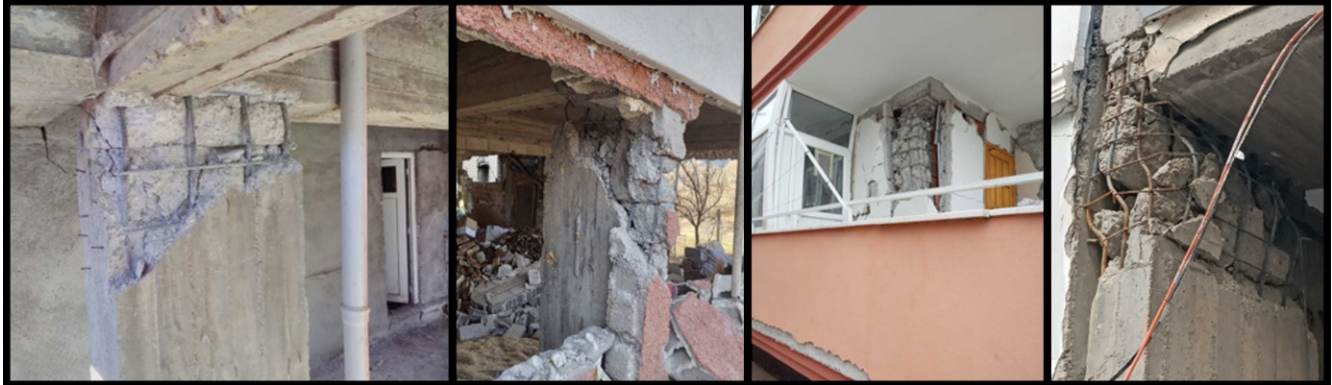
In RC columns, having ribbed longitudinal reinforcements and plain transverse reinforcements negatively affects the combined behavior of these reinforcements under loads, leading to inadequate anchorage and adversely impacting the expected functions of the reinforcements. Examples of damage observed in columns with ribbed longitudinal reinforcements and plain transverse reinforcements are shown in Figure 13.

**Figure 13.** Use of different types of reinforcement.

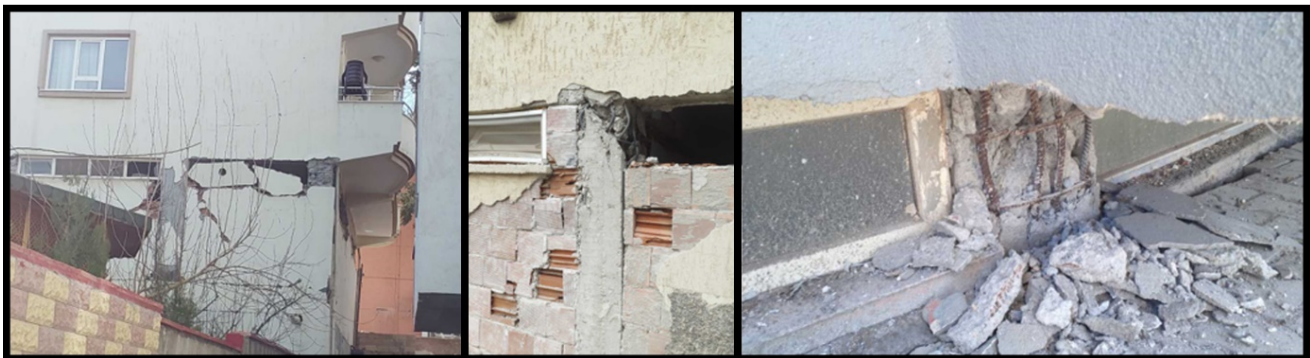
Short column-induced damage is among the frequently observed structural failures following earthquakes. Variations in column heights within a structure can occur due to several factors. In this case, although a reduction in column height enhances structural stiffness, it concurrently decreases the moment arm length. Short columns, due to their limited height relative to other dimensions, experience reduced lateral displacement under horizontal loads. This can lead to increased shear forces, causing structural damage at different levels. Examples of damage in short columns are presented in Figure 14.

**Figure 14.** Examples of damage caused by short columns.

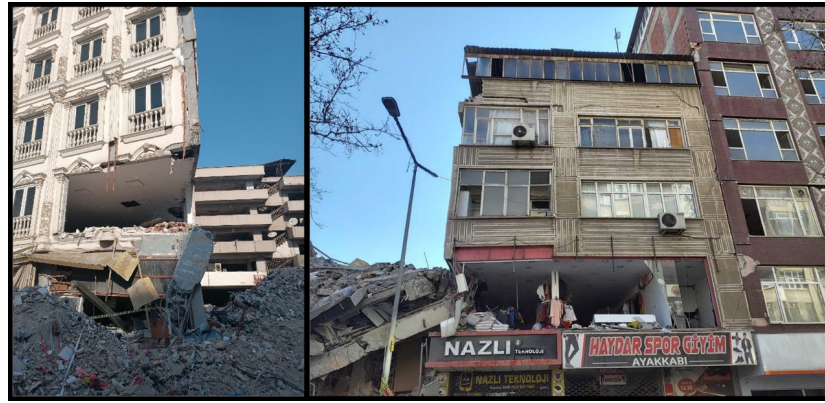
Another reason for the damage in columns is the additional shear forces created in the columns of neighboring buildings due to the pounding effect during an earthquake, especially in buildings constructed in a combined arrangement. This additional shear force can exceed the expected shear force for the load-bearing element, leading to damage. Examples of damage in the columns of neighboring structures resulting from the pounding effect are shown in Figure 15.

Figure 15. Damage due to the pounding effect.

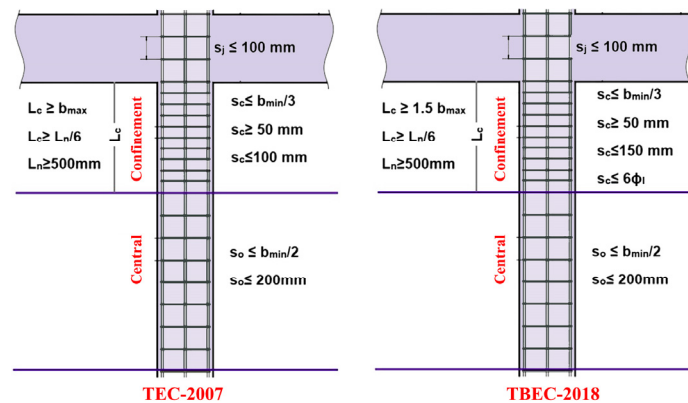
The requirements for transverse reinforcement in RC columns, as specified in the last two seismic design codes used in Türkiye, are illustrated in Figure 16.

Figure 16. Transverse reinforcement requirements for RC columns according to last two seismic design codes [86,87].

Post-earthquake field investigations indicated that the transverse reinforcement spacing in both the confinement (core) and central regions of the columns exceeded the code-specified limits. In several RC columns, transverse reinforcement was entirely absent. Moreover, special seismic ties required by TBEC-2018 were found to be completely omitted. Additionally, transverse reinforcements were anchored to the longitudinal bars at  $90^\circ$ , rather than the prescribed  $135^\circ$ , compromising their confinement effectiveness. Insufficient concrete cover further contributed to reinforcement corrosion and a reduction in bond strength. These combined deficiencies hindered the composite action of transverse and longitudinal reinforcements during seismic loading, resulting in their separation.

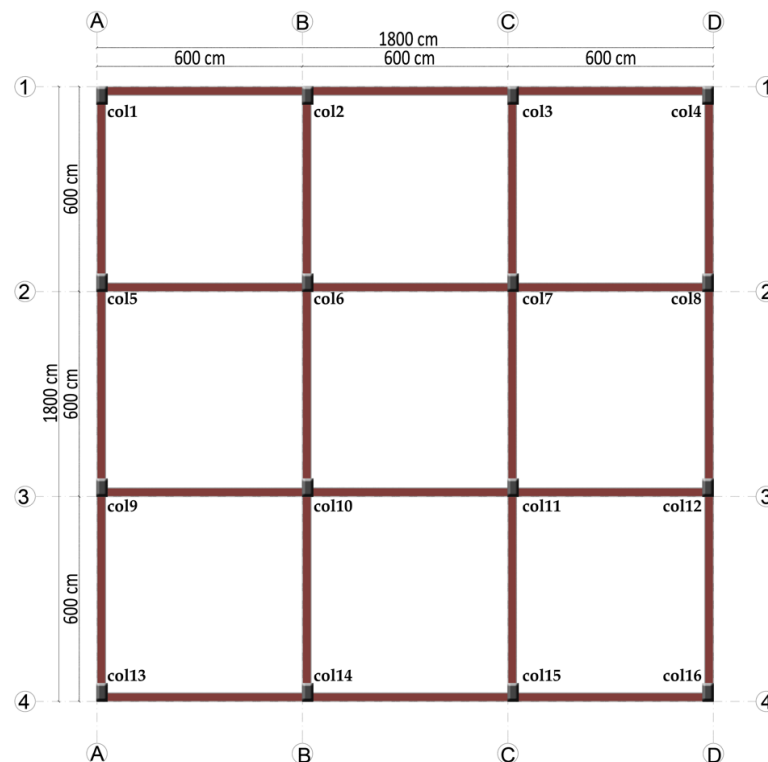
The selected RC structure model has three spans in each direction, with each span chosen to be 6 m. The floor plan of the RC structure model and the representation of the columns are shown in Figure 17.

**Figure 17.** Floor plan and naming of the columns.

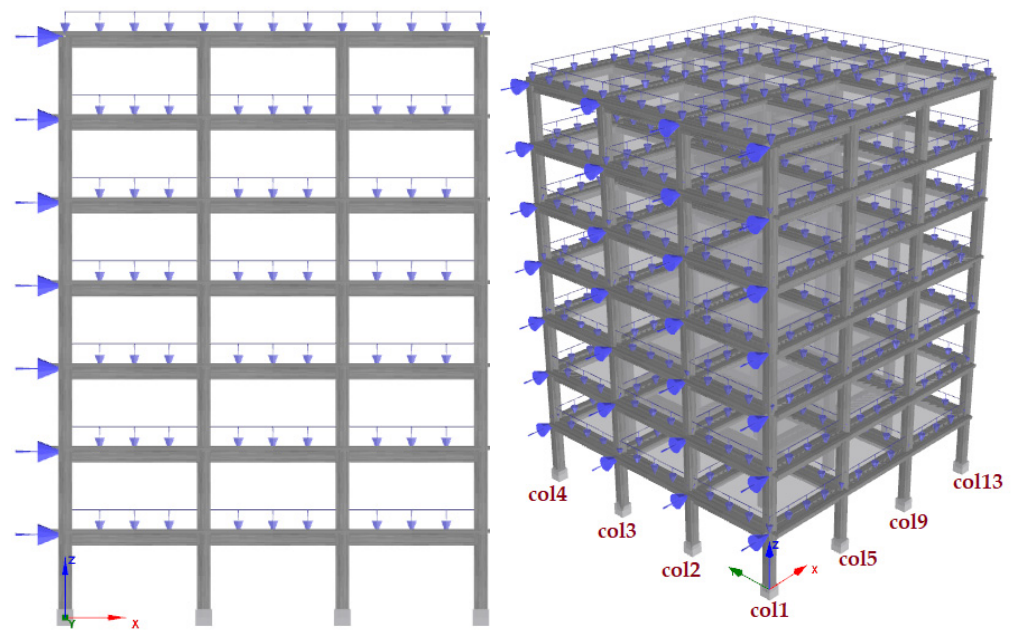
The 2D and 3D visuals of the constructed building model are shown in Figure 18.

**Figure 18.** 2D and 3D models of the selected RC structure model.

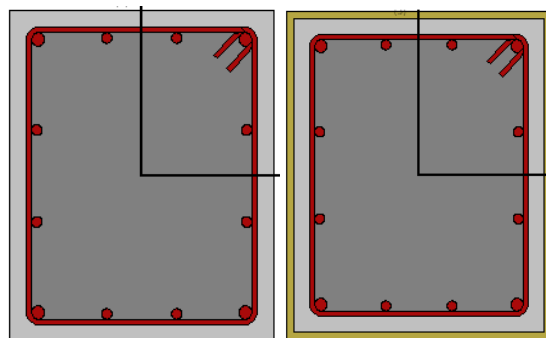
The cross-sections of the columns considered in the numerical analyses before and after reinforcement are shown in Figure 19.

**Figure 19.** The cross-sections of the columns before and after reinforcement.

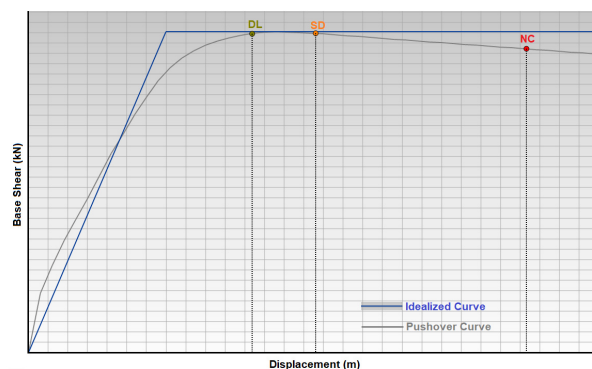
Pushover analysis was used in all structural models. Pushover analysis, a numerical technique, investigates the extent of deformation and the behavior of structures or structural elements under a specific load. This type of analysis typically considers both elastic and plastic responses. Pushover analysis is widely employed in earthquake engineering to predict how a structure will respond during seismic events. The method evaluates the deformation of a structure subjected to static loads (usually simulating ground motion) and identifies the point at which damage may occur. It is less complex and faster to perform than more advanced dynamic analyses. This approach enables the assessment of displacement, rotation, and potential damage locations within the structure [94–97]. Uniform load distributions were taken into account in all structural analyses. For the models considered in this study, the period, base shear force, as well as the elastic and effective stiffness values, were first obtained. Additionally, the target displacements specified in Eurocode-8 [98] which are commonly used worldwide, namely damage limitation (DL), significant damage (SD), and near collapse (NC), were separately determined. The target

displacements taken into consideration are shown in Figure 20. All target displacements for structural models are presented in the Table 3.

**Figure 20.** Typical pushover and idealized capacity curves (DL: damage limitation; SD: significant damage; NC: near collapse).

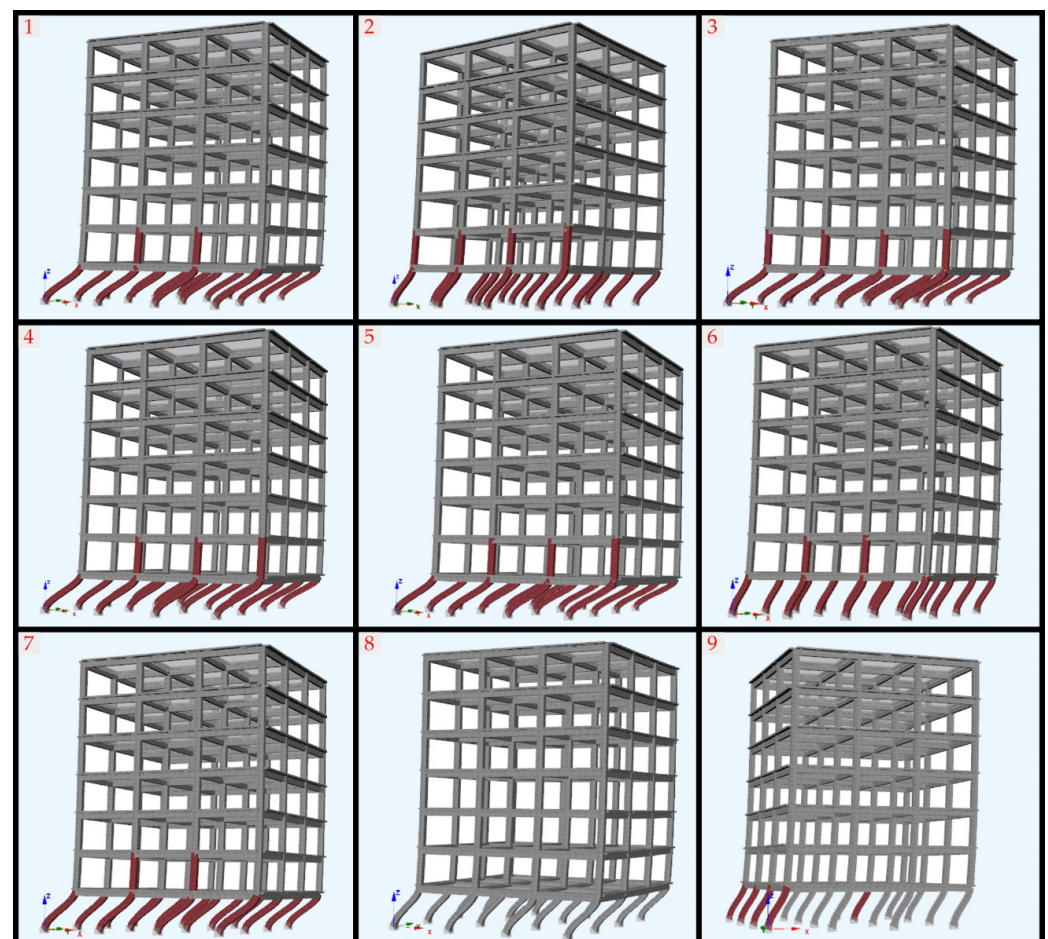
The shear force deformation states obtained for all models considered in the study and the representation of columns exceeding the shear force limit are shown in Figure 21.

**Figure 21.** Shear force deformation states and columns exceeding the limit (the number of each figure corresponds to the number of model).

With the increase in the spacing of transverse reinforcements, the number of columns exceeding the shear force limit has increased. However, with the increase in concrete strength, there is a significant reduction in the number of columns with shear force exceedance. Both the spacing of transverse reinforcements and concrete strength significantly affect the performance of columns under shear force. Additionally, factors such as reinforcement layout, concrete cover thickness, reinforcement workmanship, and reinforcement quality will directly impact the damage that may occur under shear force effects in these elements. Insufficient spacing of transverse reinforcements can lead to buckling of longitudinal reinforcements and brittle behavior of the core concrete. As a result of structural analyses and field investigations, it is essential that transverse reinforcements be applied with precision as specified in earthquake regulations.

As seen in Figure 18, when the concrete strength is C30/37, there are no column elements that exceed the shear force limit. This indicates that concrete strength directly

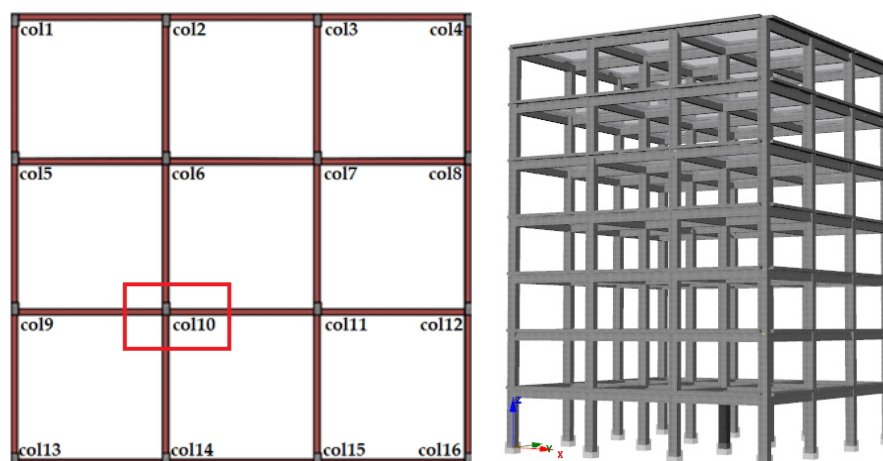
In this study, the strengthening with FRP was performed on Model 3, which had the lowest concrete strength and the maximum spacing of transverse reinforcement, as part of the structural analyses. Initially, the FRP strengthening method was evaluated using a single column. For this purpose, col10 located on the first floor was selected as an example (FRP-1). The representation of the selected column on the floor plan and its 3D model are shown in Figure 22.

Figure 22. FRP application in Col10 column.

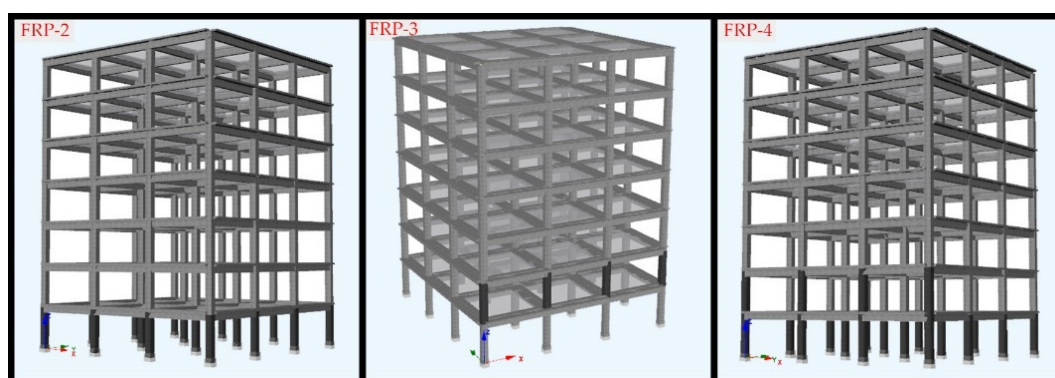
To evaluate the FRP strengthening more comprehensively, three additional FRP strengthening models were created, still considering Model 3, which has the worst conditions. The structural models resulting from the FRP strengthening applied to each of the three models are shown in Figure 23. In the FRP-2 model, FRP was applied to all columns on the ground storey where the shear force limit was exceeded for Model 3. In the FRP-3 model, FRP was applied only to the columns on the second storey that exceeded the shear force limit values. In the FRP-4 model, FRP was applied to all columns where the shear force capacity was exceeded on both the first and second stories (Figure 24).

Figure 23. Models strengthened with FRP.

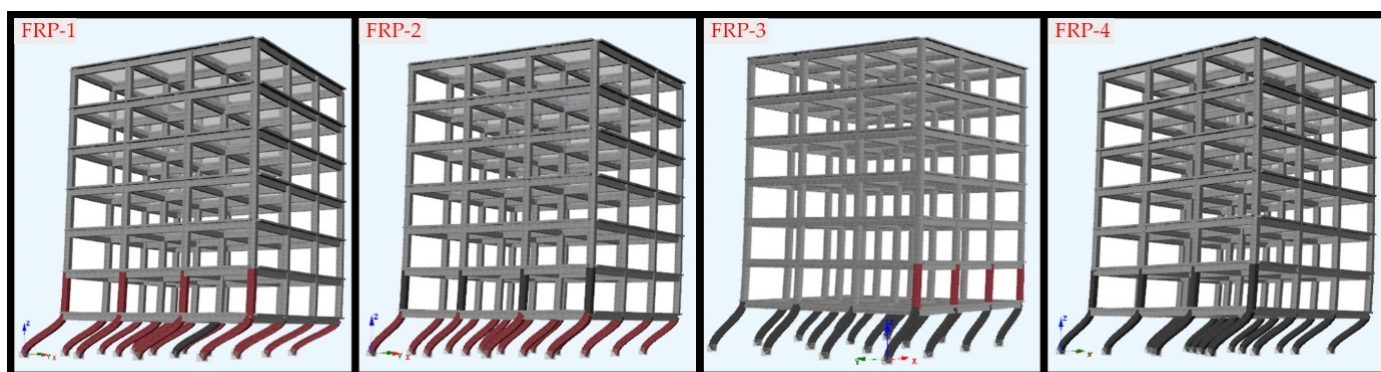
Figure 24. Shear force capacity damage states obtained for the models strengthened with FRP.

In the FRP-1 model, all columns, except the strengthened column (Col10), exceeded the limit shear force. In the FRP-2 model, as all columns on the ground floor were strengthened, they all satisfied the limit shear force requirement. Conversely, on the un-strengthened second floor, the majority of the columns surpassed the limit value. In the FRP-3 model, where only the second floor was strengthened, the columns on this floor did not exceed the limit value. However, all un-strengthened columns on the ground floor exceeded the limit value. In the FRP-4 model, the strengthening of columns on both floors ensured that all columns satisfied the limit shear force criterion. It is clearly seen that the FRPs used in the models provide a significant contribution to increasing the shear force in the columns at different positions, thus eliminating capacity overshoot. In this way, reinforcements can be used in damaged reinforced concrete buildings as well as in increasing the strength of
