Seismic Performance and Failure Mechanisms of Reinforced Concrete Structures Subject to the Earthquakes in Türkiye

Abstract: Many reinforced-concrete structures collapsed or were seriously damaged in the 7.7 and 7.6 magnitude earthquakes that occurred in southern Türkiye on 6 February 2023. The recorded peak ground accelerations were quite high (2.2 g) and the recorded motions' elastic acceleration response spectra were significantly greater than the elastic design spectra given by the most recent Turkish seismic design code. A total of 518,000 houses were heavily damaged or collapsed in the eleven cities affected by the earthquake. More than 53,000 people lost their lives and over 100,000 people were injured, the majority of these injuries caused by the collapse of reinforced concrete structures. Post-earthquake damage assessments are important in the context of applying sustainability principles to building design and construction. In this study, post-earthquake damage assessments and evaluations were made for the reinforced-concrete structures that were exposed to destruction or various structural damage in Hatay, Kahramanmaraş and Adıyaman, which were most affected after the K

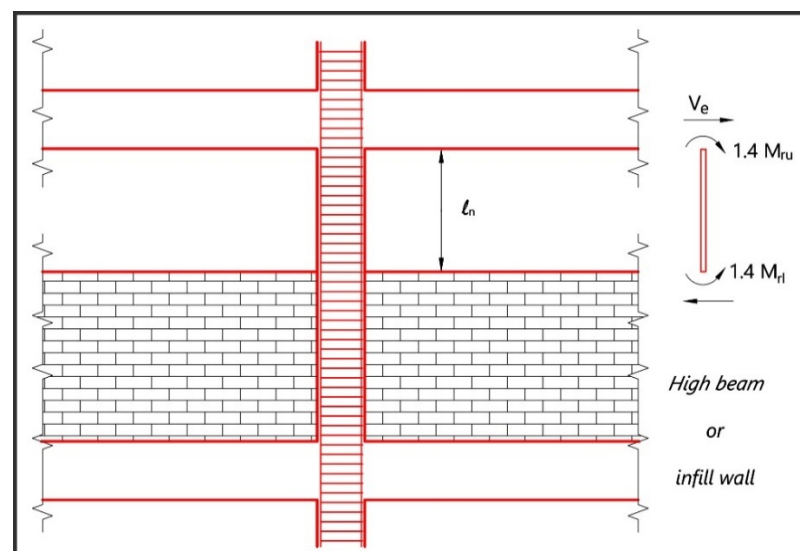
Figure 12. Transverse reinforcement in short column [77].

In short column design, minimum transverse reinforcement and placement conditions defined for confined boundary regions must be applied throughout the entire column. If the infill walls are completely adjacent to the columns, transverse reinforcement will be continued throughout the entire floor height for the columns that work as short columns (Figure 12).

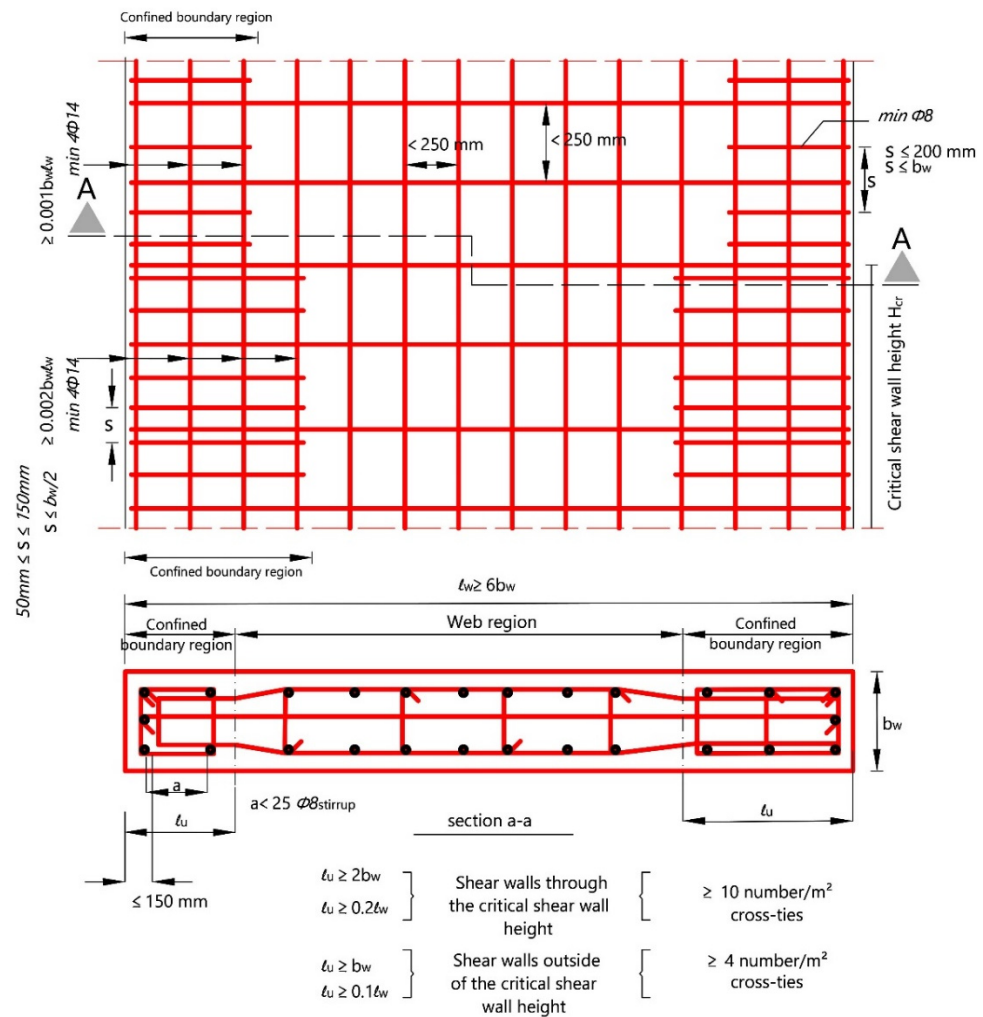
Figure 17. RC shear walls section and reinforcement detail [77].

The shear walls section and reinforcement detail in the currently used earthquake regulations are given in Figure 17.

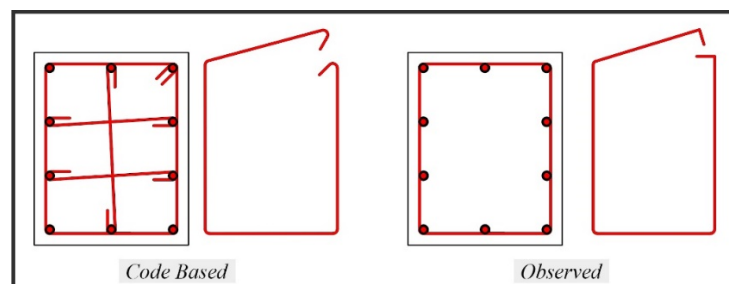
Figure 25. Correct and incorrect application of the stirrup.

The stirrups end commonly have 90° hooks and do not overlap in damaged columns in the earthquake region. It is specified that closed stirrups with 135° hooks are used, and the stirrups interlock into the core concrete in Turkish Standards. Correct and incorrect applications of the stirrup according to the Turkish standard are illustrated in Figure 25.

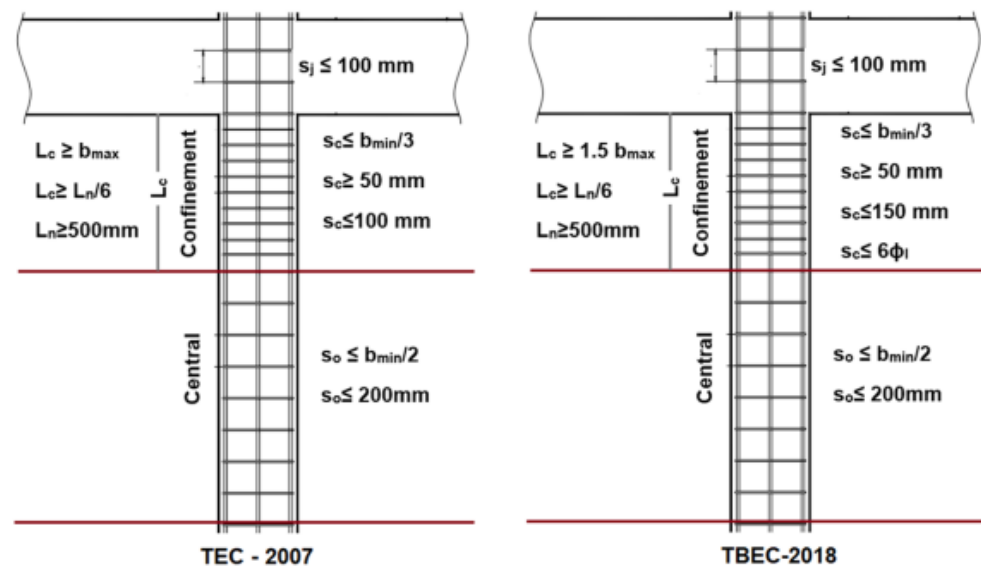
Figure 27. Comparison of the last two earthquake regulations in Türkiye [77,79].

A comparative representation of the transverse reinforcement conditions in columns and beams in the last two earthquake codes is shown in Figure 27.

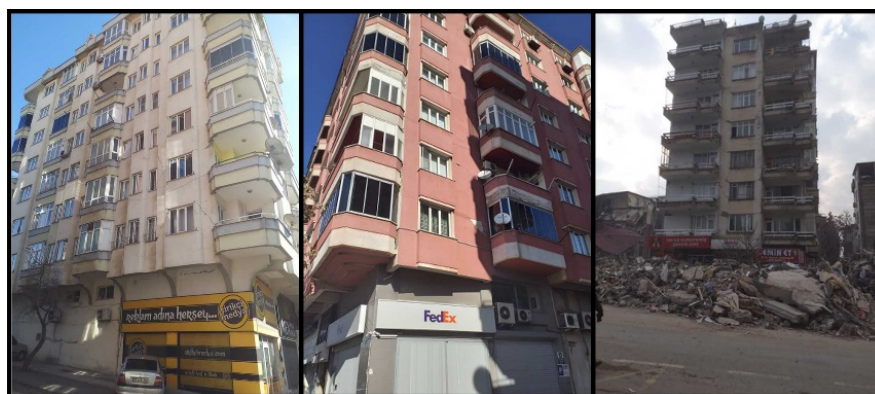
Although many structures around them collapsed during the earthquake, many structures resist the earthquake and provide life safety performance levels. Some such buildings are shown in Figure 34.

Figure 34. Some buildings that provide life safety.

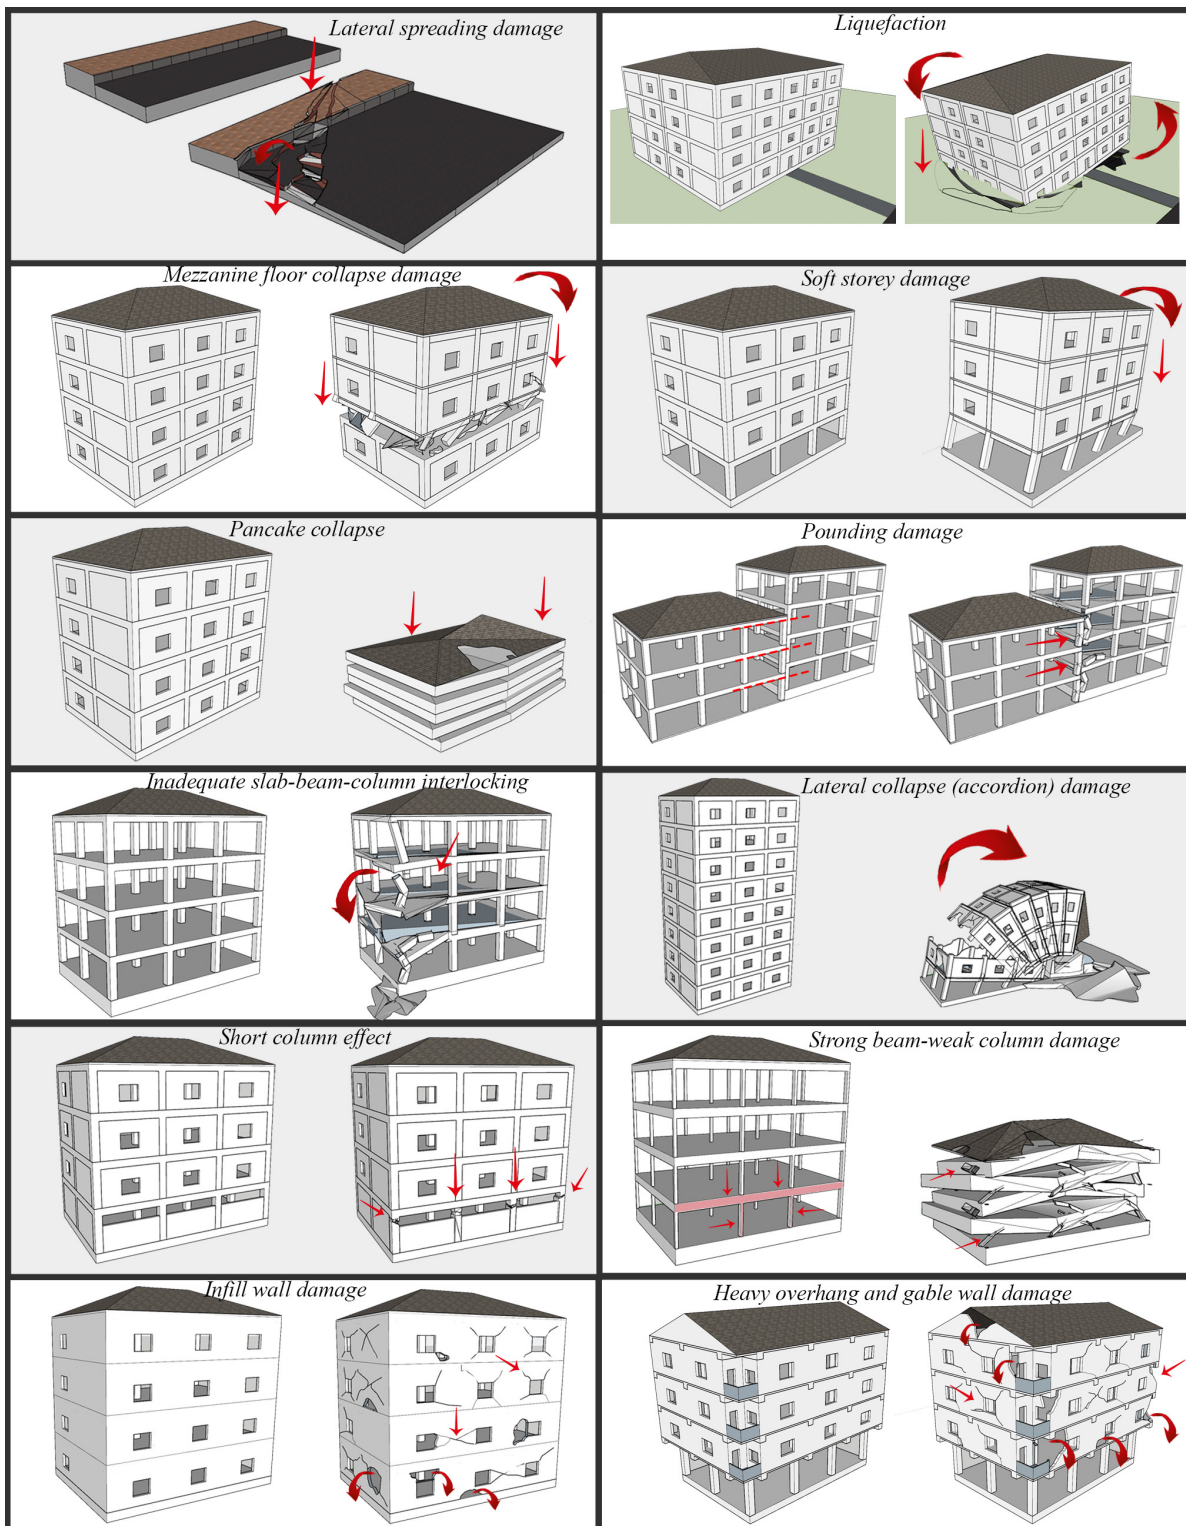
Schematic representations of reinforced concrete structure failures are shown in Figure 35. Schematic representations of the types of damage encountered in the observations made in the earthquake area are also shown in Figure 36.

Figure 35. Representations of structural failure.

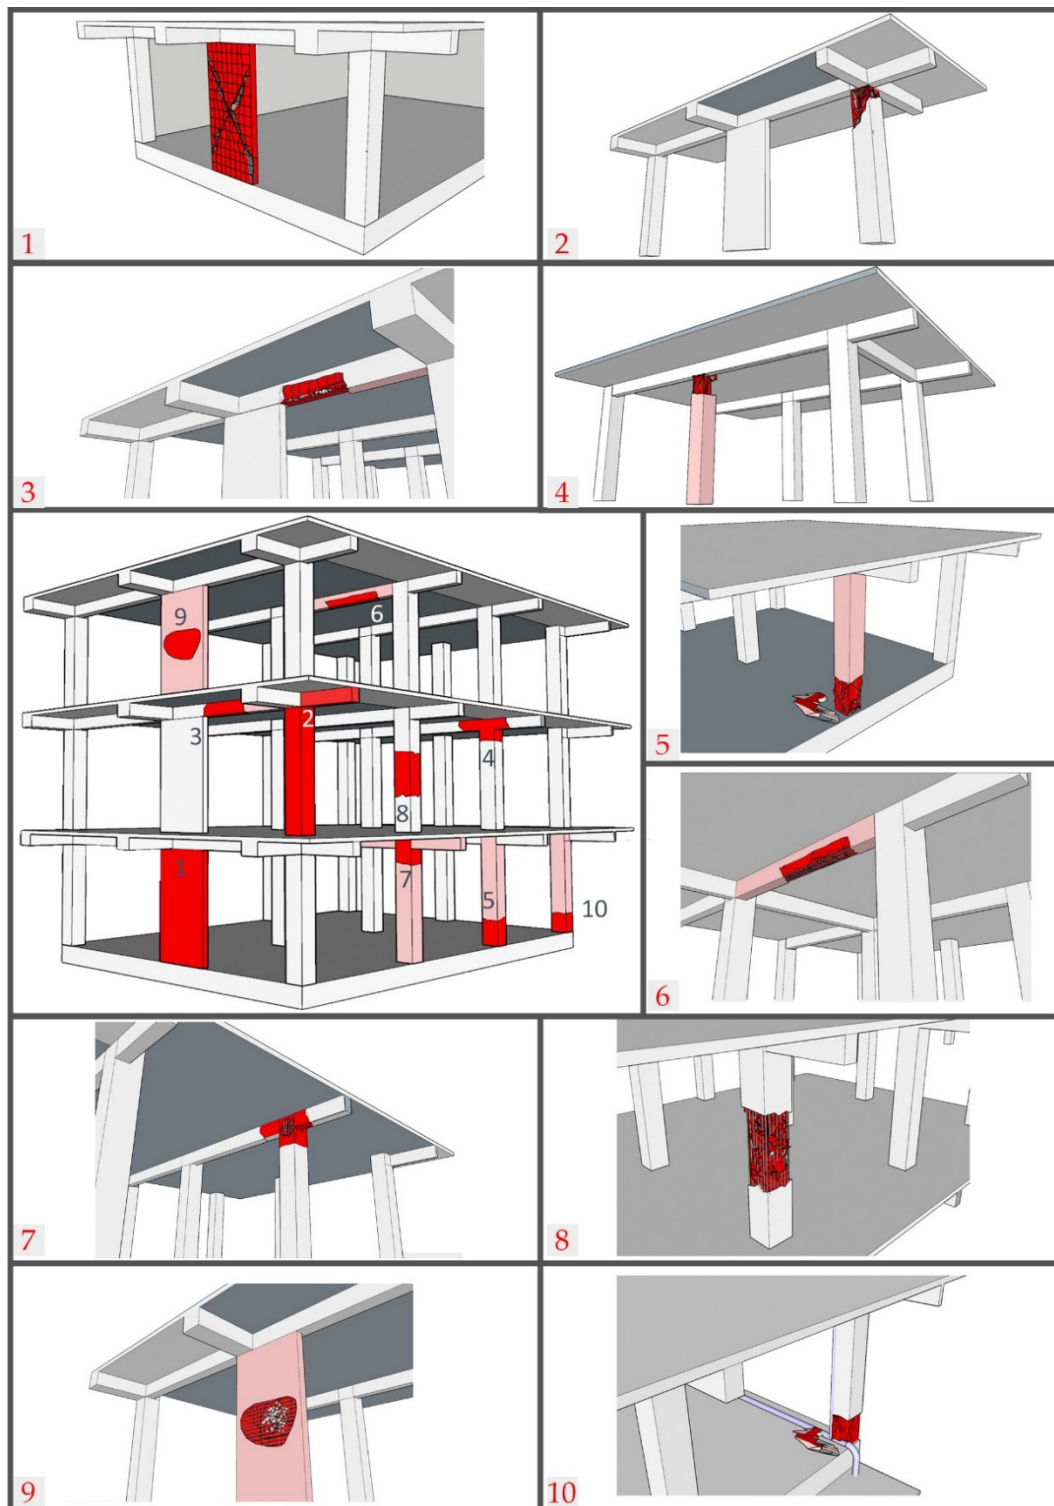
Figure 36. Schematic representation of damage. (1) RC shear wall. (2) Plastic hinge damages due to the cantilever beam effect. (3) Insufficient concrete cover and corrosion of reinforcement. (4) Plastic hinge damage occurring at the upper-end points of the column. (5) Plastic hinge damage occurring at the lower-end points of the column. (6) Insufficient transverse reinforcement. (7) Inadequate reinforcement details at the column–beam connection zones. (8) Low-strength of the concrete. (9) Improper aggregate granulometry. (10) Installations passing through structural system.
